# VEHICLE INSPECTION REPORT

**SH71GHJ**

## Fiat Doblo Work Up 1.6 Multijet 16V

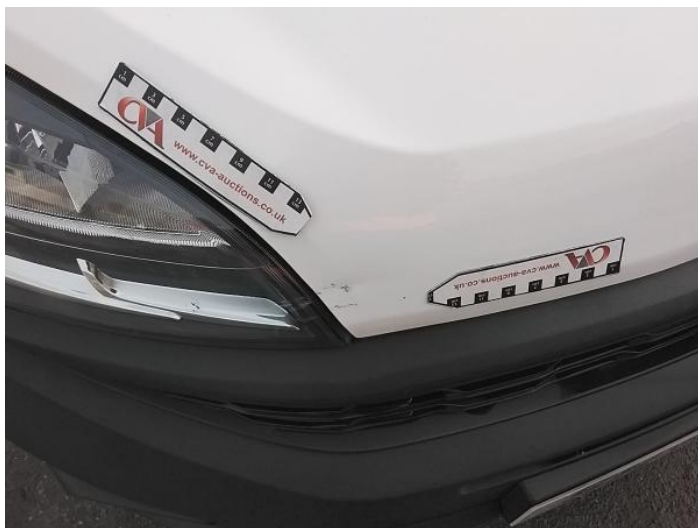
1: Bonnet  
Dented  
With Paint Damage

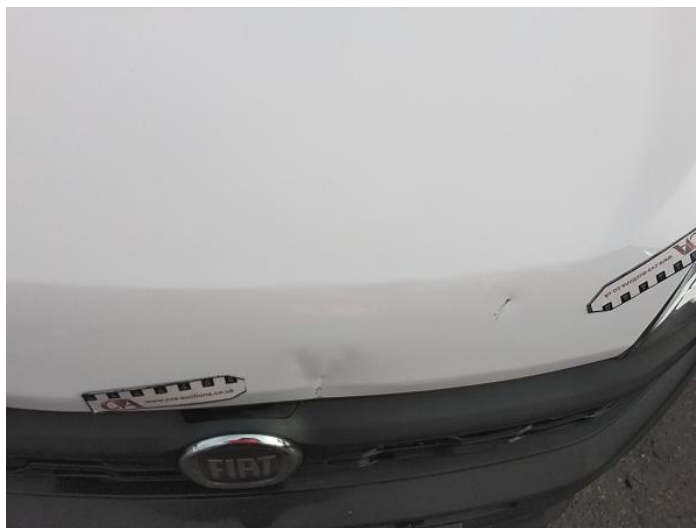
2: Bonnet  
Dented  
With Paint Damage

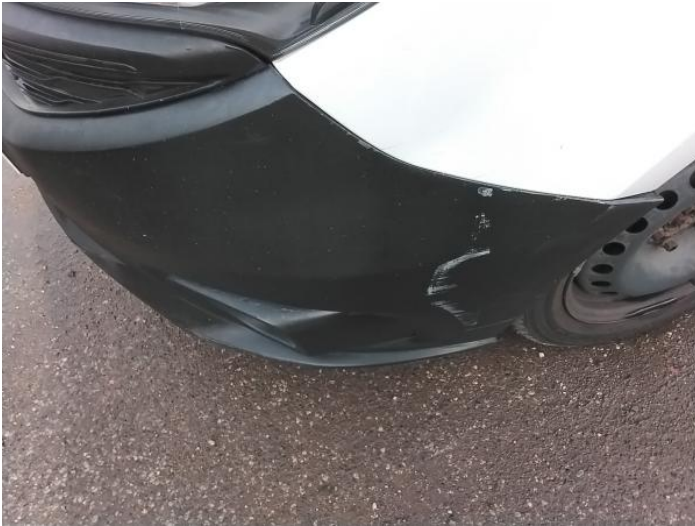
3: Bumper Front  
Scratched  
Over 100mm Thru Paint

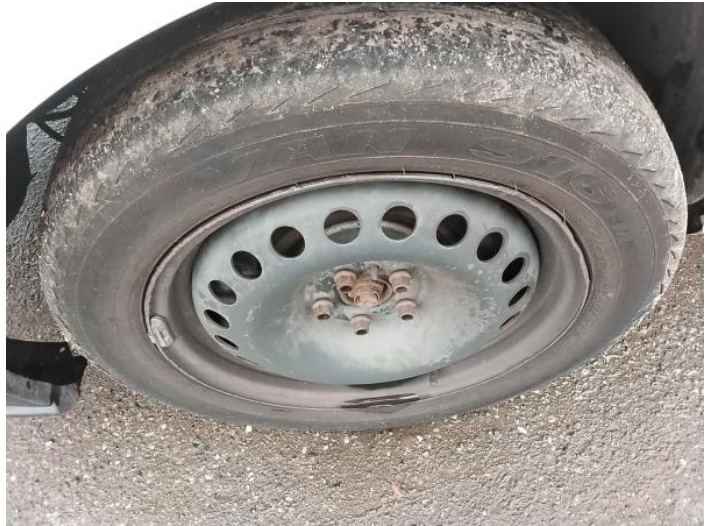
4: Wheel nsf  
Dented  
Over 30mm (Steel)

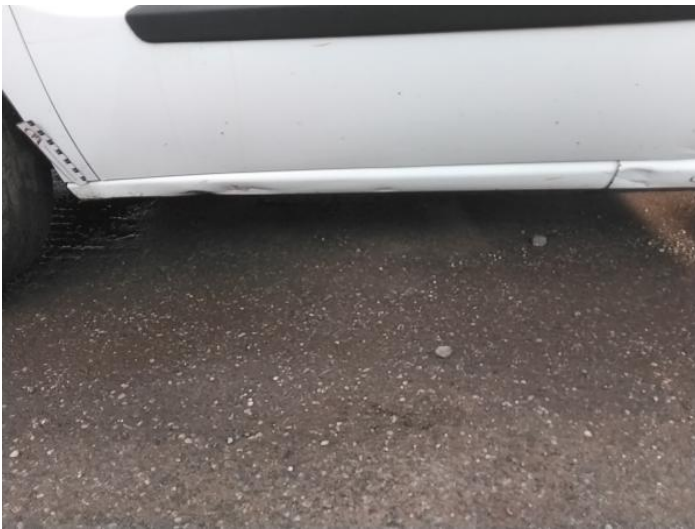
5: Sill ns  
Dented  
Over 30% Of Panel

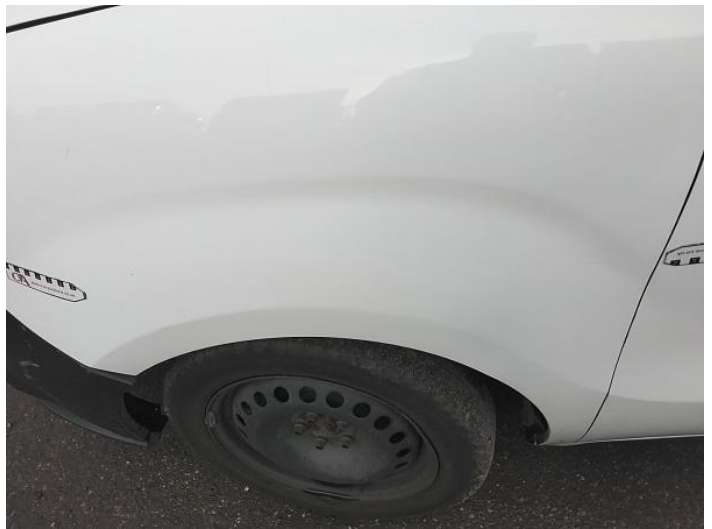
6: Wing nsf  
Scratched  
Over 25mm Thru Paint

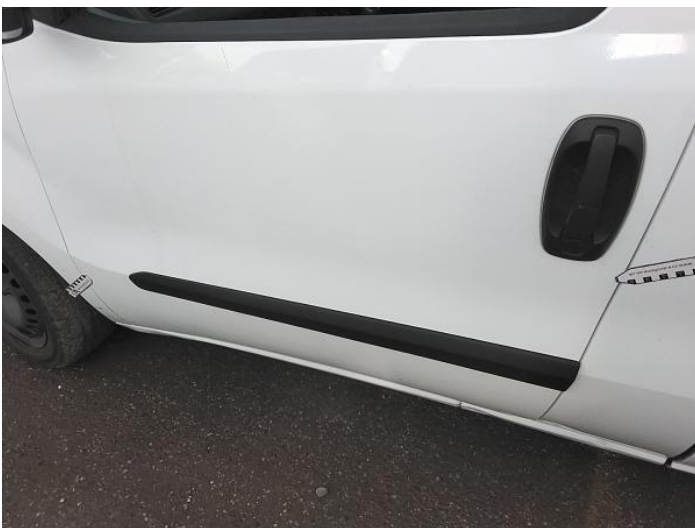
7: Door nsf  
Scratched  
Over 25mm Thru Paint

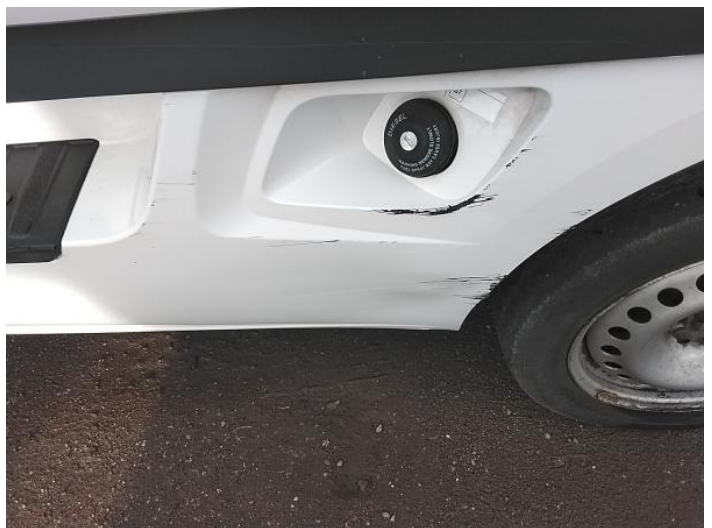
8: Qtr Panel nsr  
Dented  
With Paint Damage

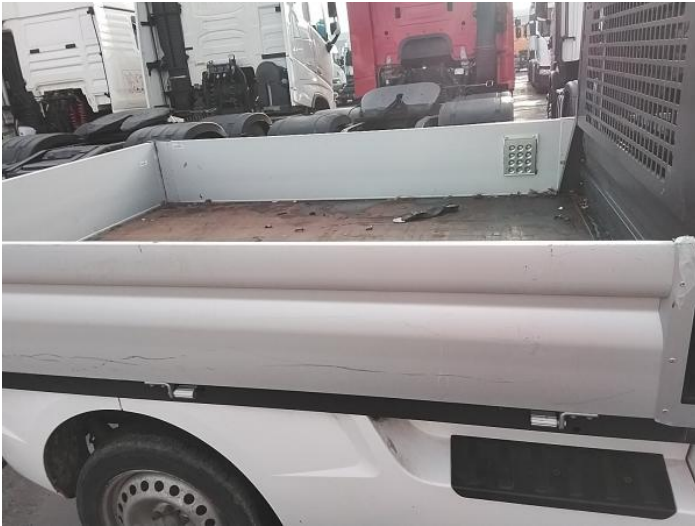
9: Qtr Panel osr  
Scratched  
Over 25mm Thru Paint

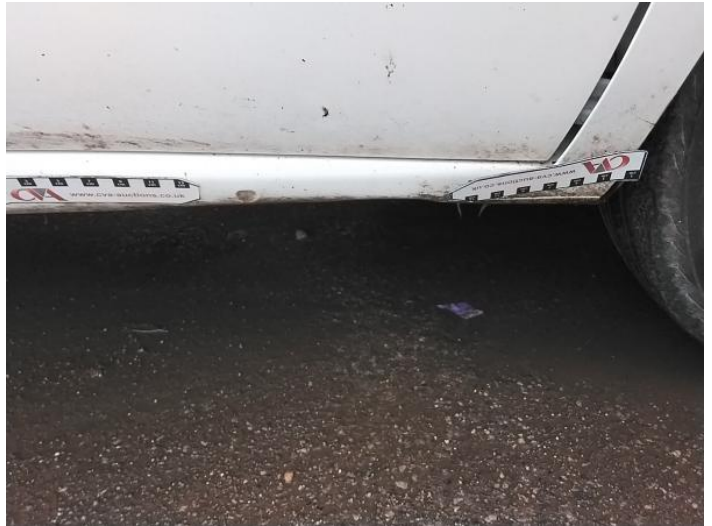
10: Sill os  
Dented  
With Paint Damage

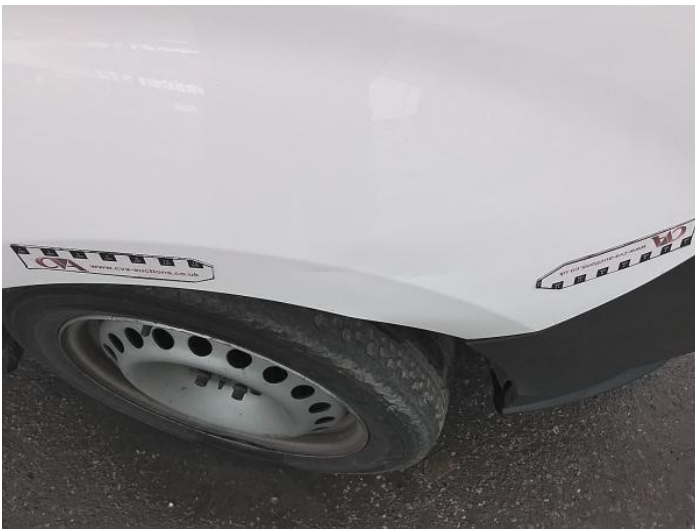
11: Wing osf  
Dented  
With Paint Damage

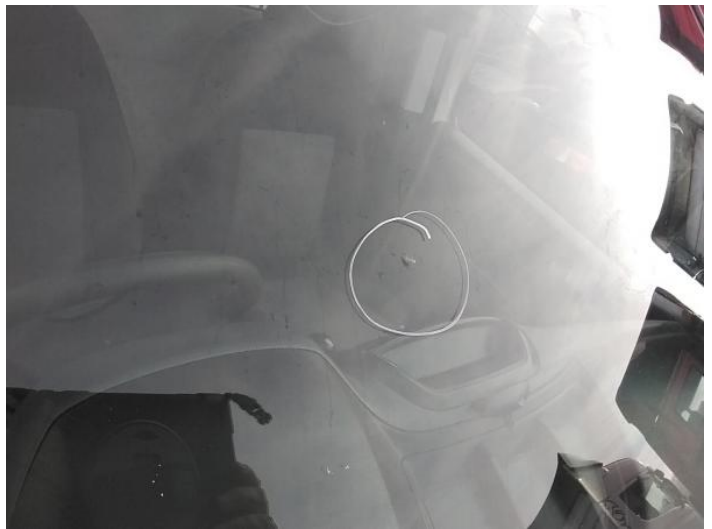
12: Screen Front  
Chipped  
Over 10mm

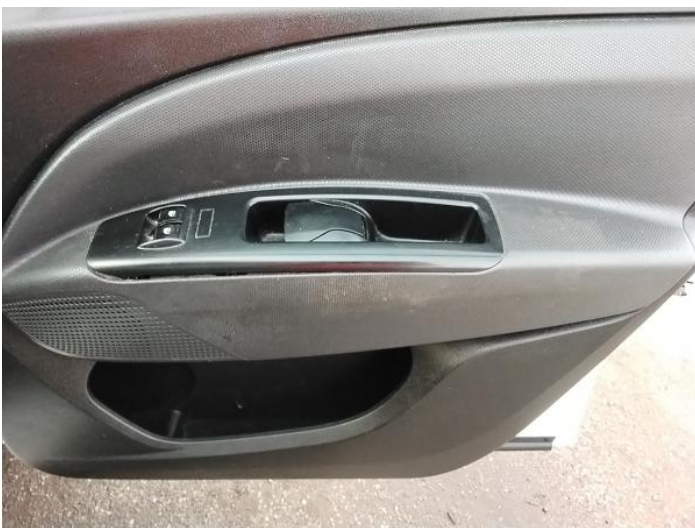
13: Door Pad osf  
Broken  
Replace

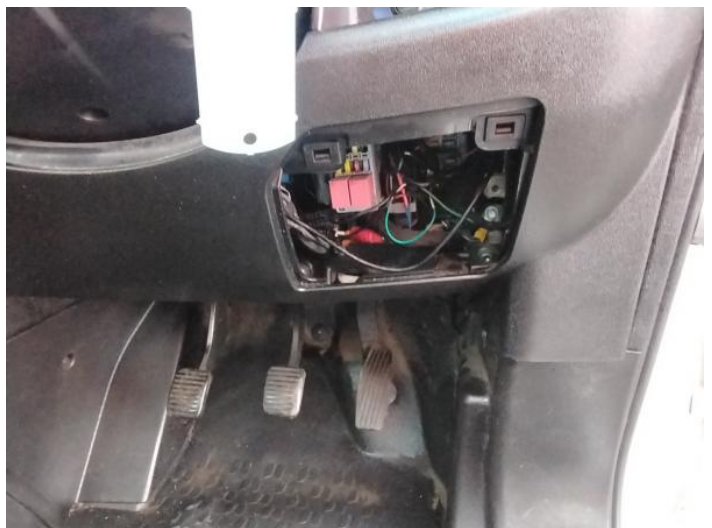
14: Fascia Panel  
Missing  
Replace

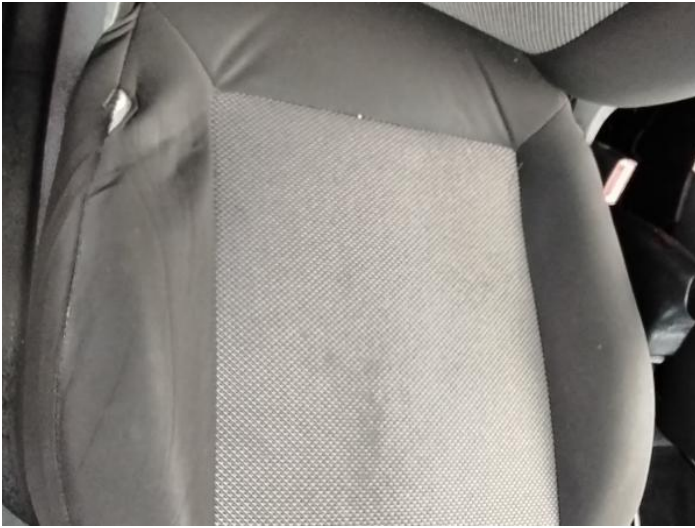
15: Seat Base Cover osf  
Torn  
Over 3mm

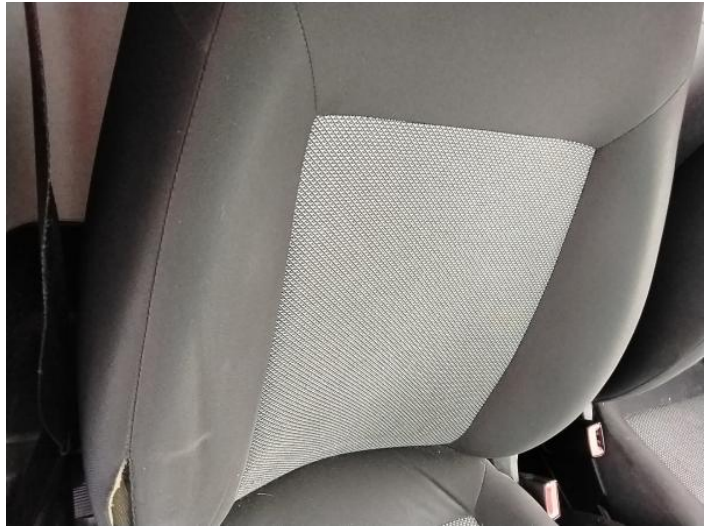
16: Seat Back Cover osf  
Torn  
Over 3mm

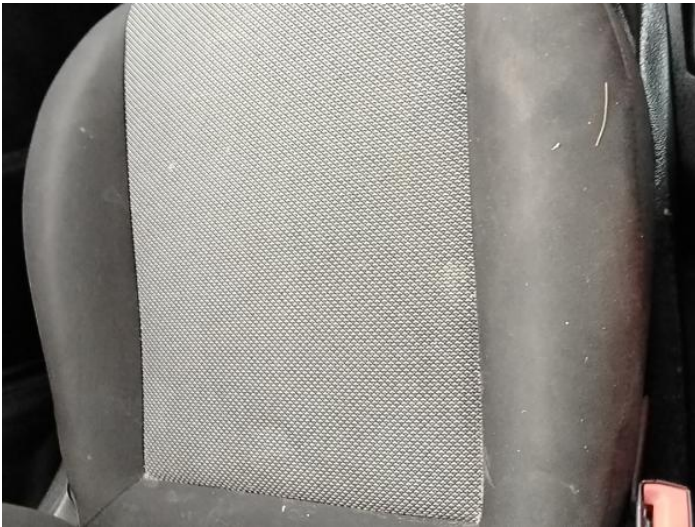
17: Seat Base Cover nsf  
Soiled  
Heavy

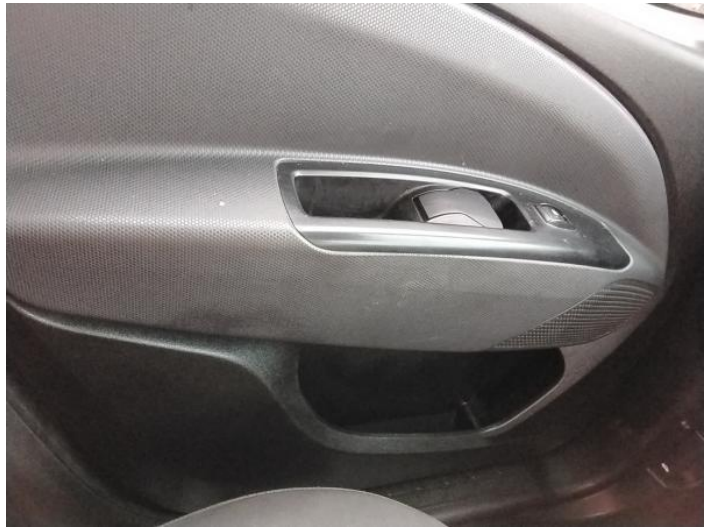
18: Door Pad nsf  
Soiled  
Heavy

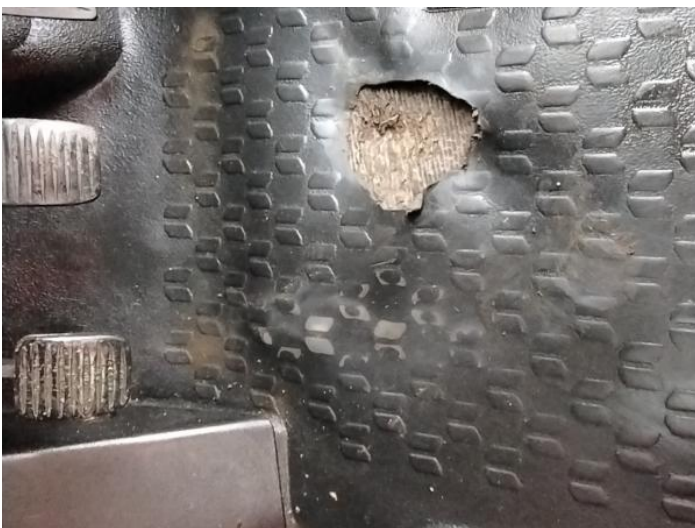
19: Carpets Front  
Holed  
Over 3mm

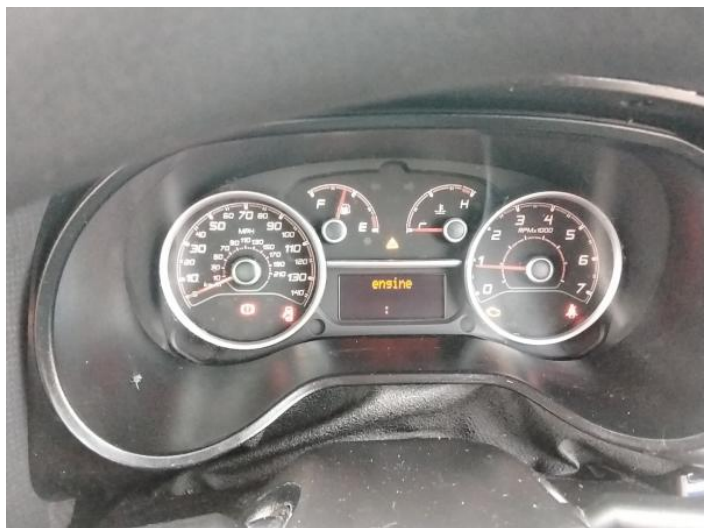
\*WARNING LIGHTS ON DASH, HANDBRAKE POOR\* AD-BLUE

20: Dash Warning Lights  
Displayed  
No Action

| EML light illuminated | Fault | DPF light illuminated | OK |
