# VEHICLE INSPECTION REPORT

**YJ13HUV**

## Vdl Futura FHD2-129

### Serious Damage Inspection

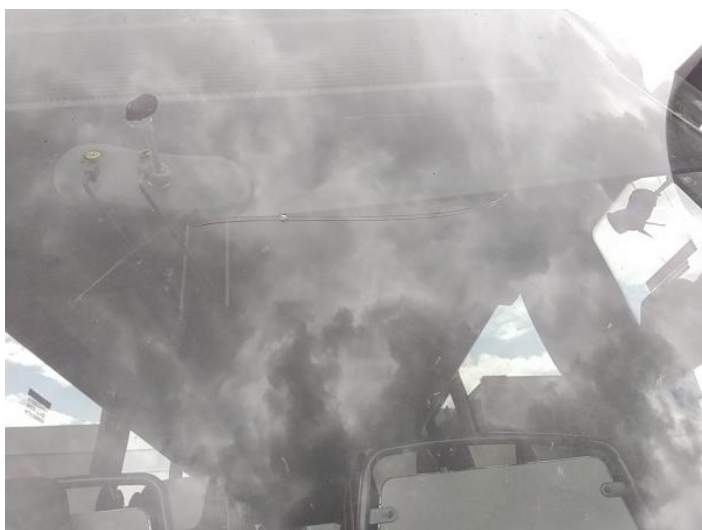
1: Screen Front  
Cracked  
Replace

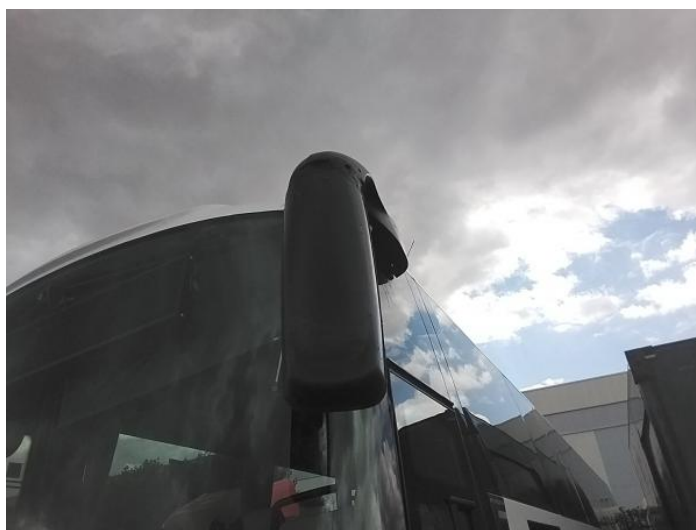
2: Door Mirror Assy nsf  
Broken  
Replace

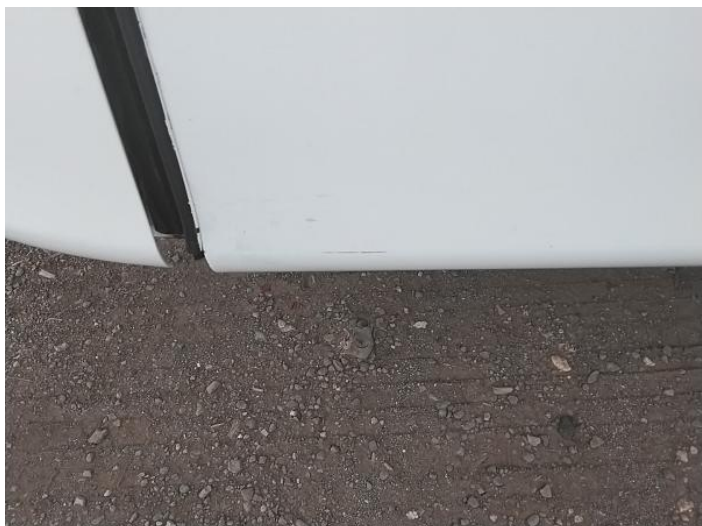
3: Door nsf  
Scratched  
Over 25mm Thru Paint

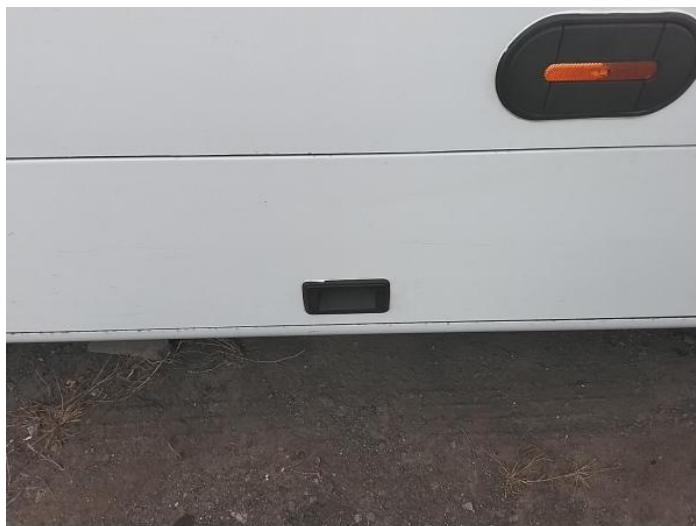
4: Qtr Panel nsr  
Scratched  
Over 25mm Not Thru Paint

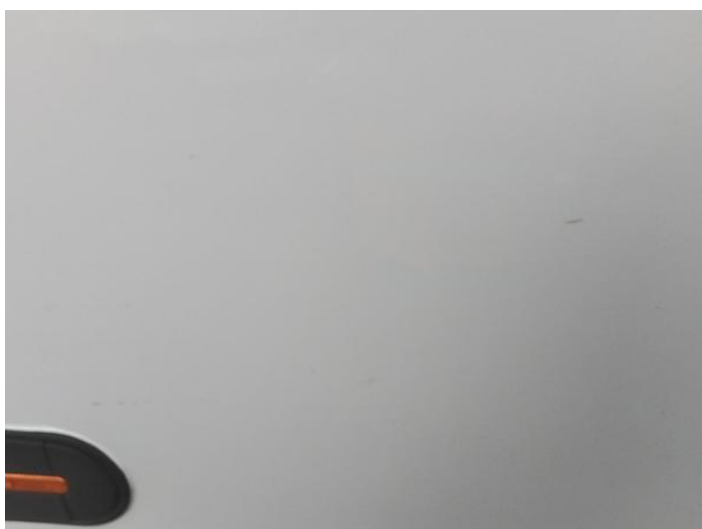
5: Qtr Panel nsr  
Scratched  
Over 25mm Thru Paint

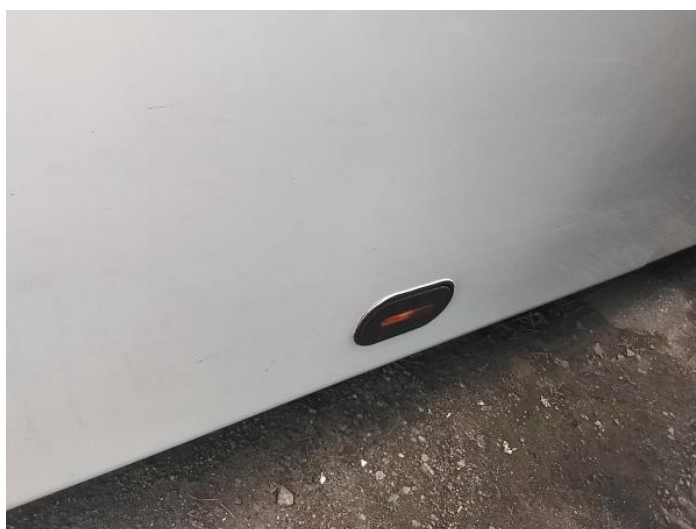
6: Qtr Panel nsr  
Scratched  
Over 25mm Thru Paint

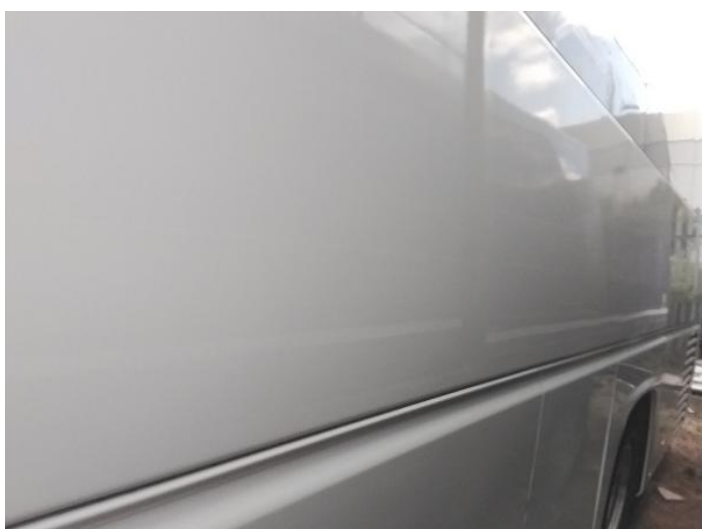
7: Qtr Panel nsr  
Scratched  
Over 25mm Thru Paint

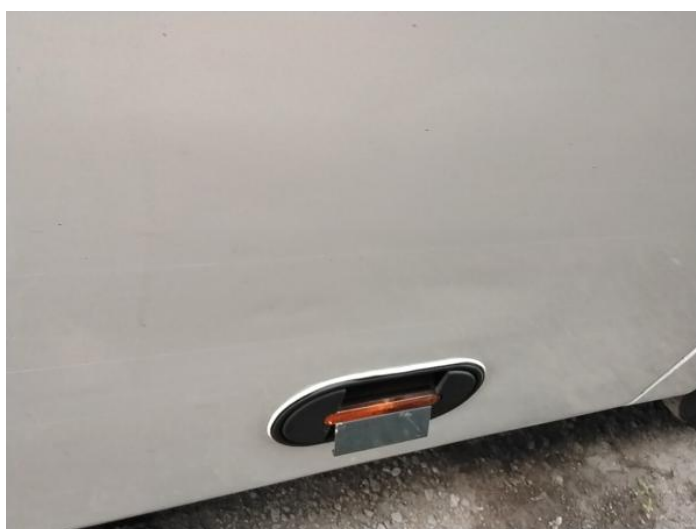
8: Qtr Panel nsr  
Dented  
Over 30mm

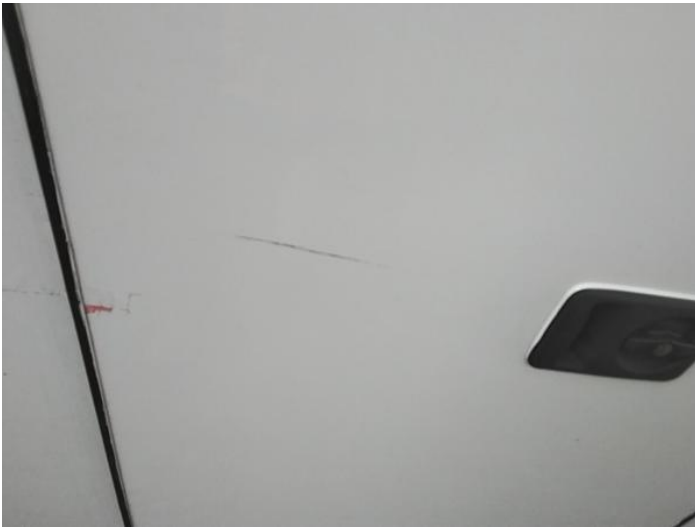
11: Door osr  
Dented  
With Paint Damage

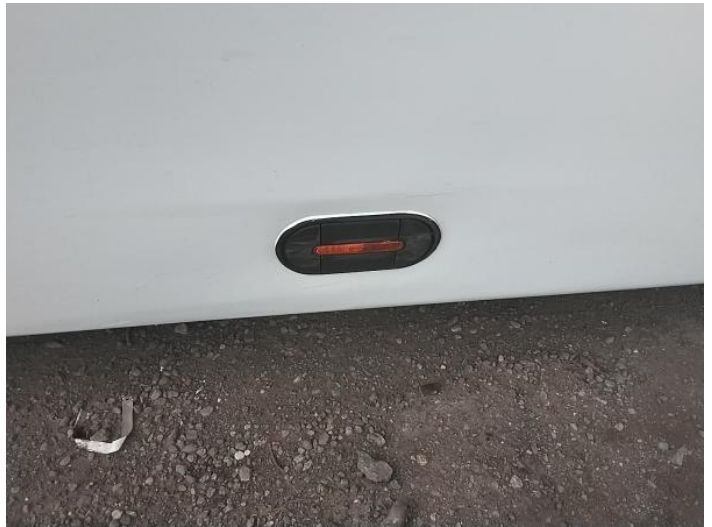
12: Qtr Panel osr  
Dented  
Over 30mm

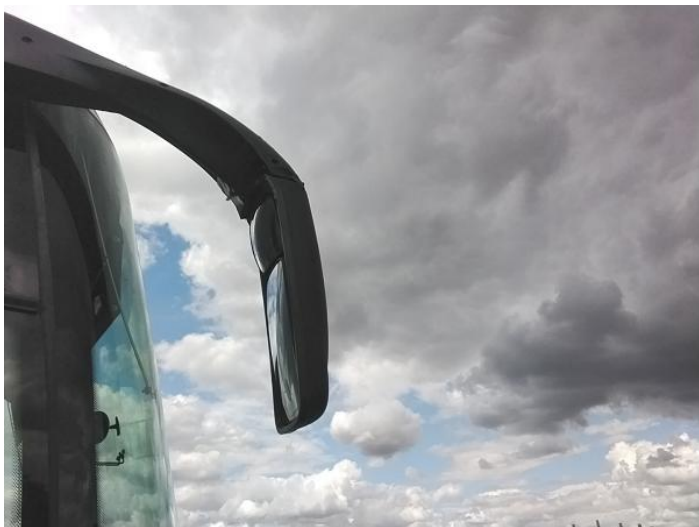
15: Door Mirror Assy osf  
Broken  
Replace

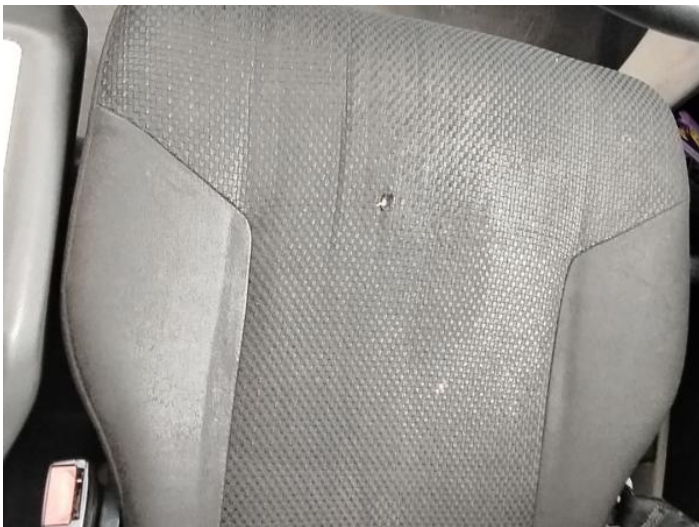
16: Seat Base Cover osf  
Holed  
Over 3mm
