## VEHICLE INSPECTION REPORT

**CU65EOY**

### Ford Transit 350 2.2 TDCI 155PS

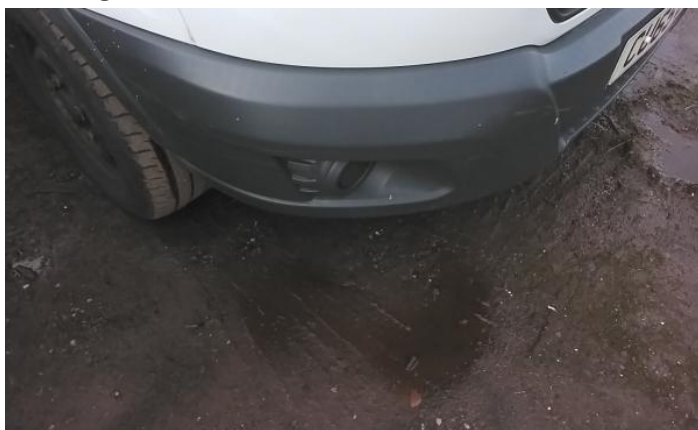
1: Bumper Front  
Scratched  
Over 100mm Thru Paint

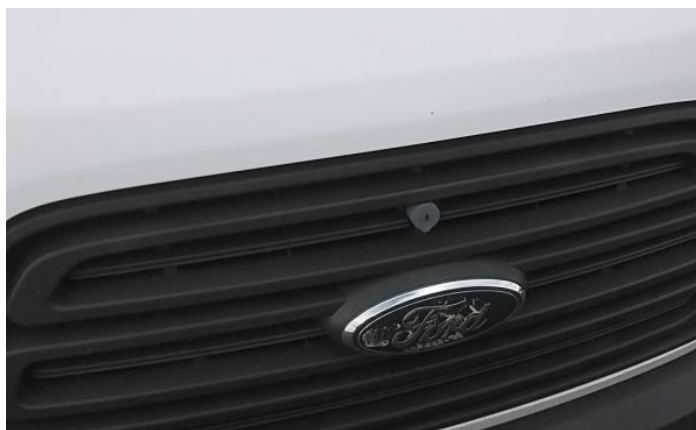
2: Bonnet  
Chipped  
Multiple Chips

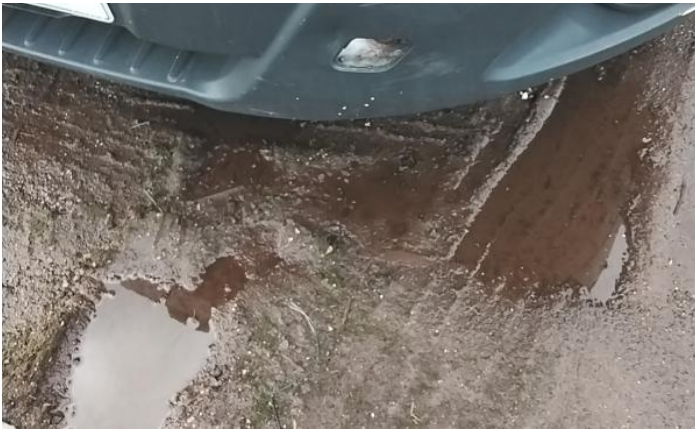
3: Bumper Front Moulding  
Missing  
Replace

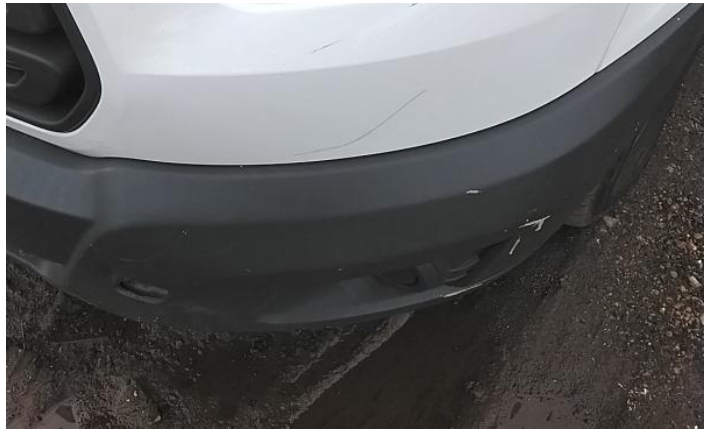
4: Panel Front  
Scratched  
Over 25mm Thru Paint

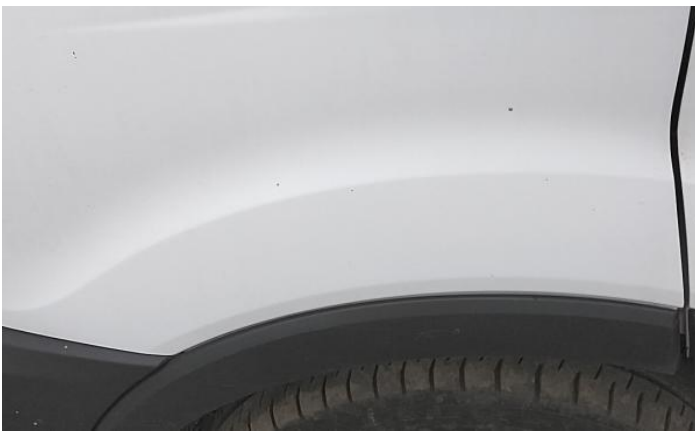
5: Wing nsf  
Chipped  
Multiple Chips

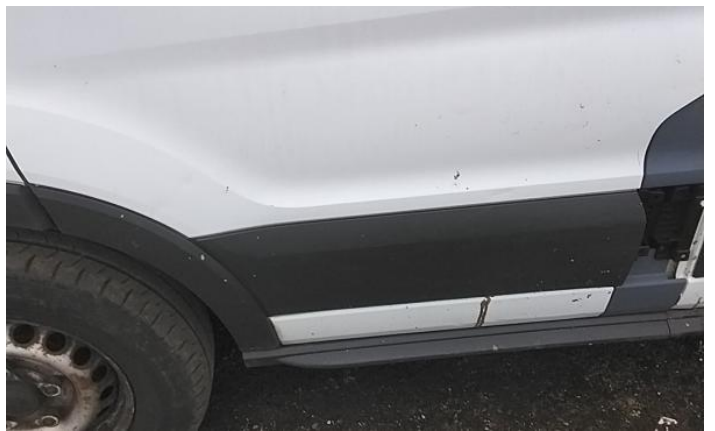
6: Door nsf  
Chipped  
Multiple Chips

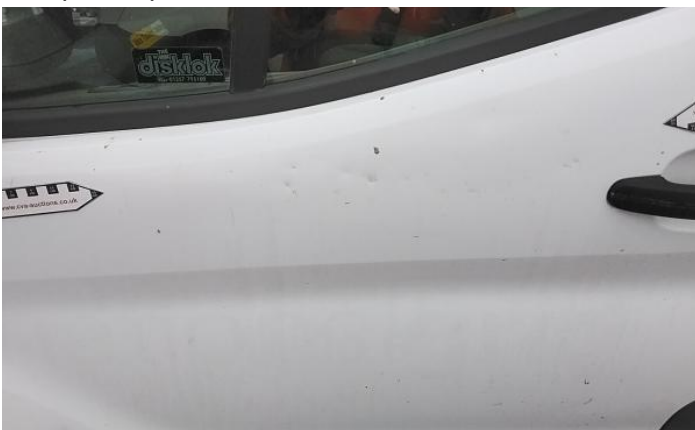
7: Door nsf  
Dented  
With Paint Damage

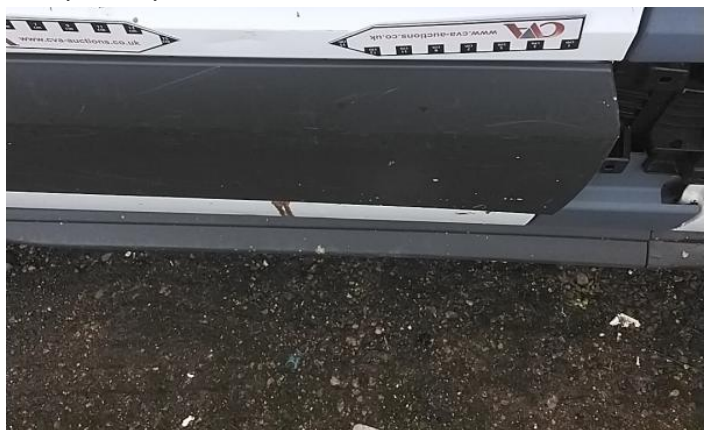
8: Door nsf  
Dented  
Over 30mm

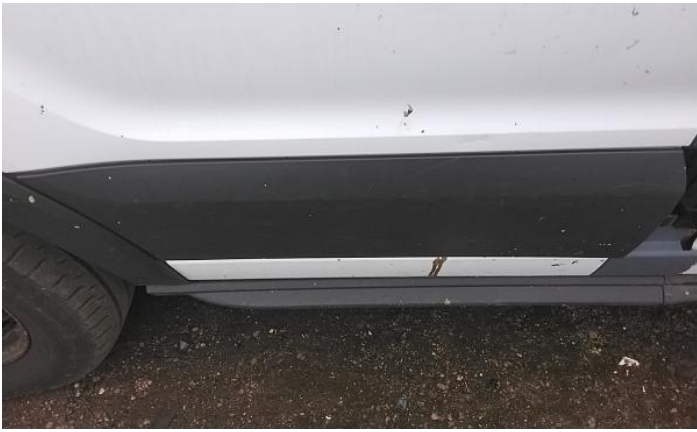
9: Door Moulding nsf  
Scuffed (Unpainted)  
Over 100mm

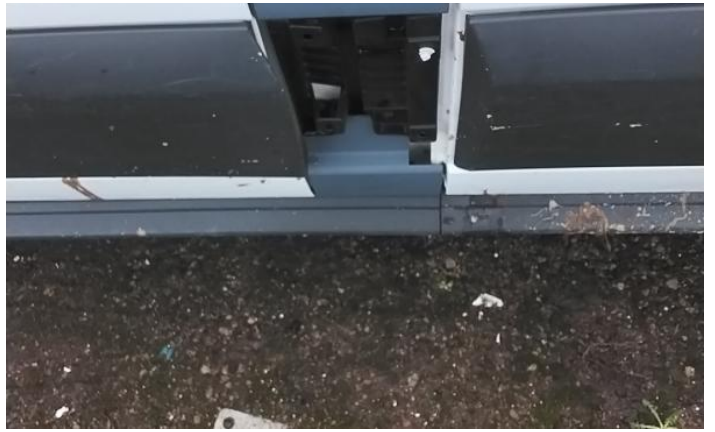
10: Door Moulding nsf  
Missing  
Replace

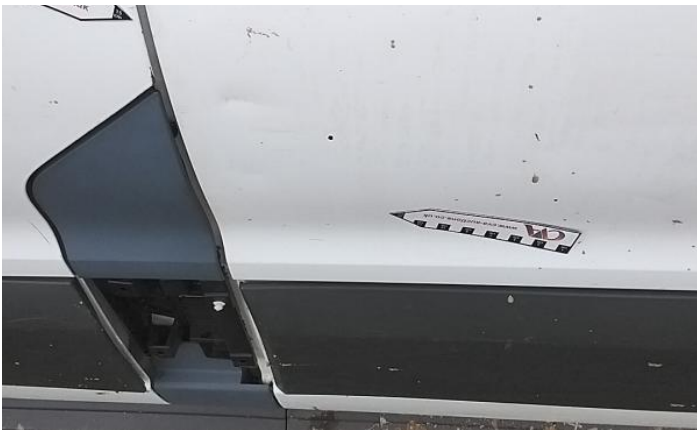
13: Qtr Panel nsr  
Dented  
With Paint Damage

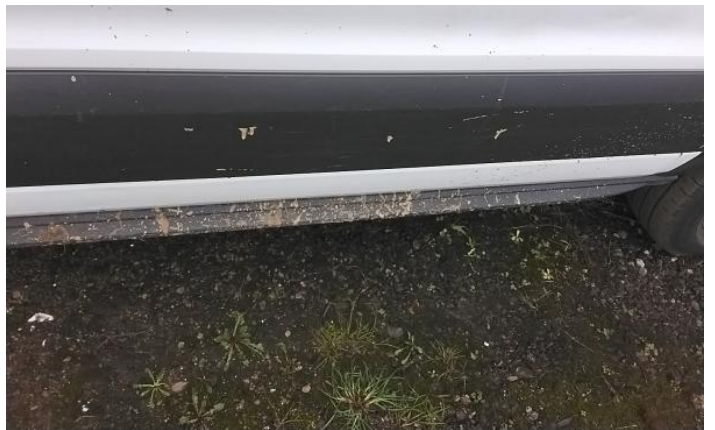
14: Qtr Panel Moulding ns  
Scuffed (Unpainted)  
Over 100mm

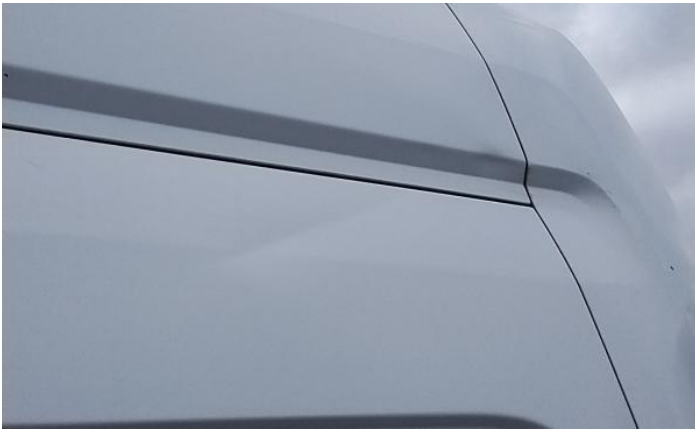
15: Qtr Panel nsr  
Dented  
Over 30mm

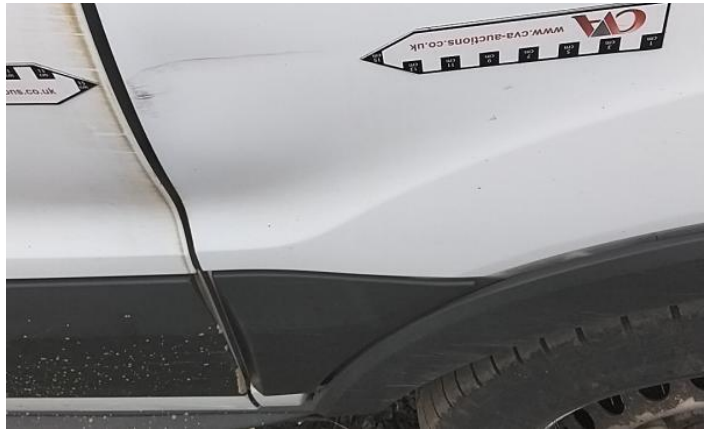
16: Qtr Panel nsr  
Dented  
With Paint Damage

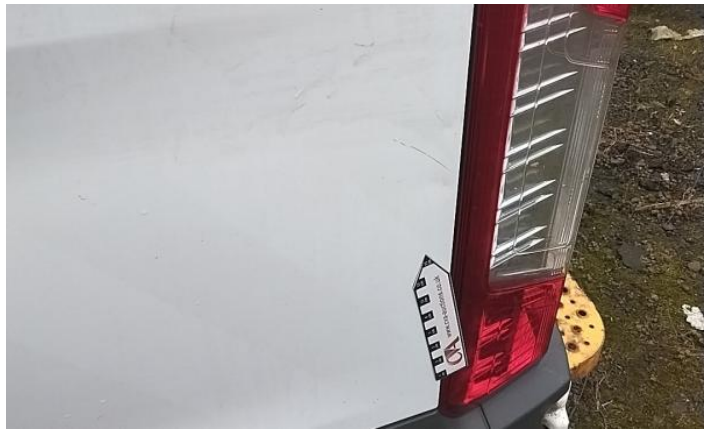
18: Qtr Panel nsr  
Dented  
With Paint Damage

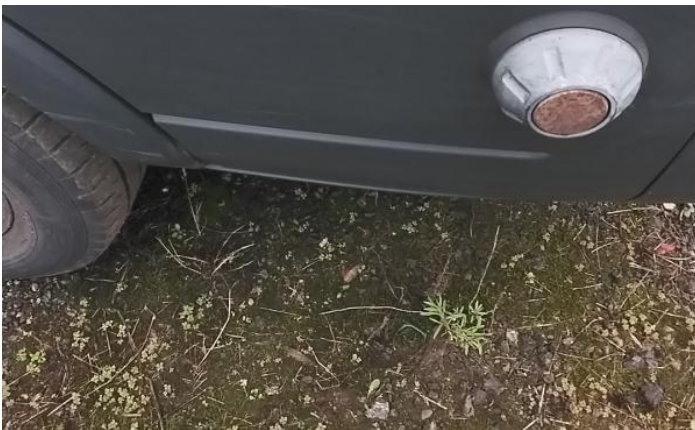
19: Qtr Panel Moulding ns  
Scuffed (Unpainted)  
Over 100mm

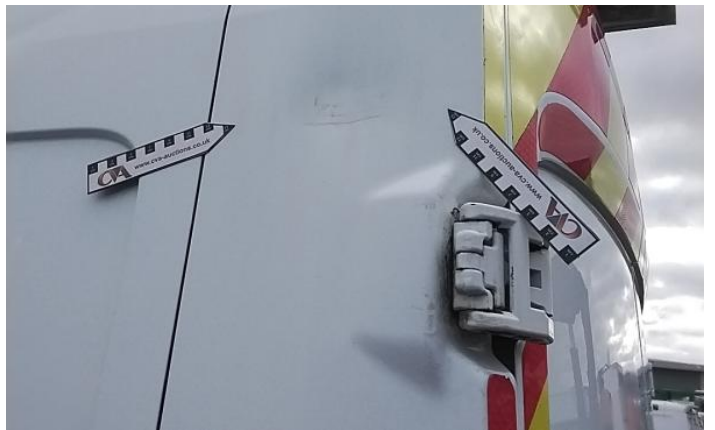
20: C Post ns  
Dented  
With Paint Damage

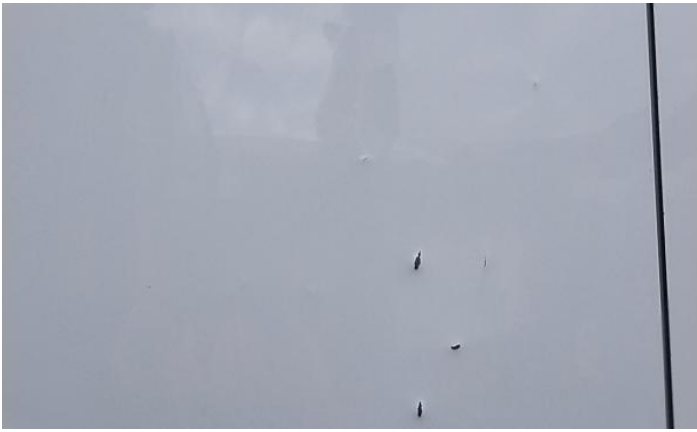
21: Door nsr  
Dented  
With Paint Damage

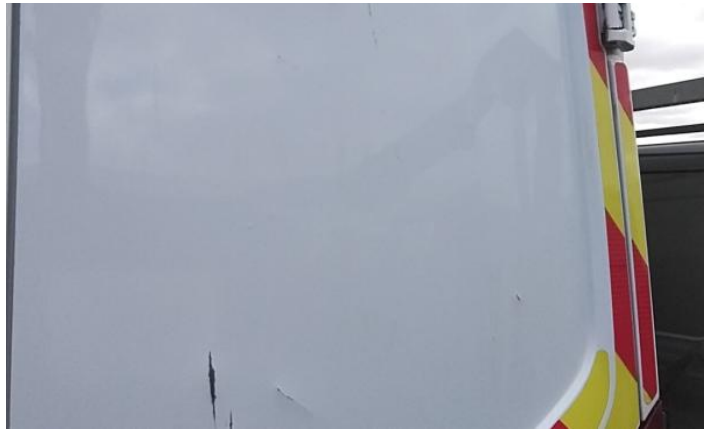
22: Door osr  
Dented  
Over 30% Of Panel

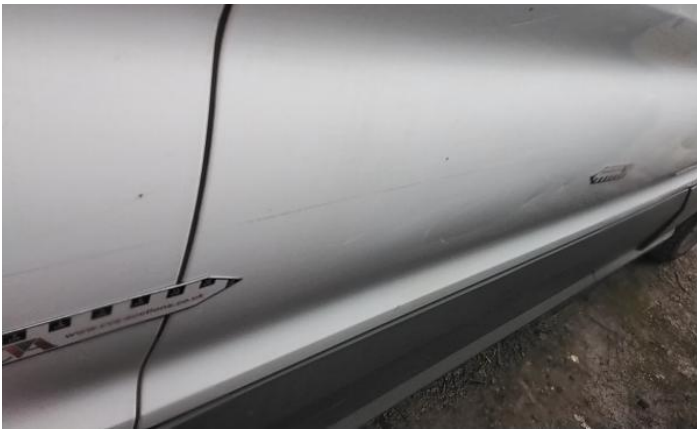
23: Qtr Panel osr  
Dented  
With Paint Damage

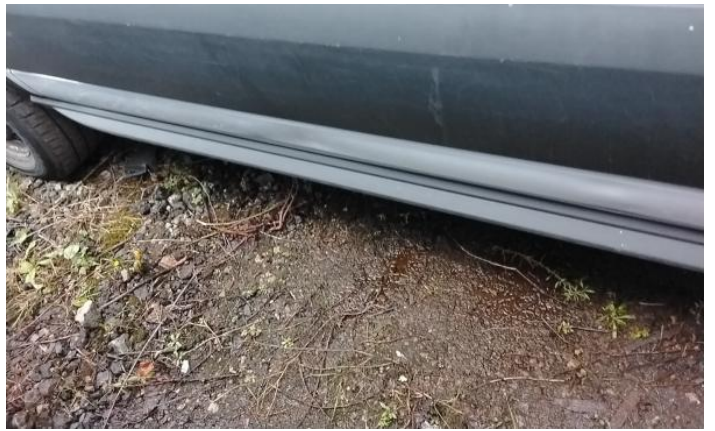
24: Qtr Panel Moulding os  
Scuffed (Unpainted)  
Over 100mm

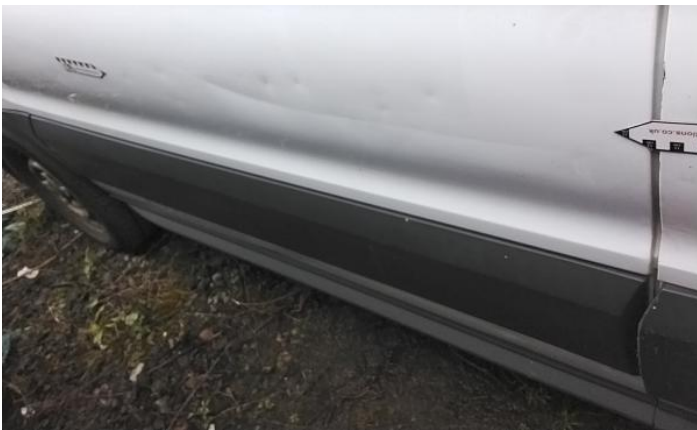
25: Qtr Panel osr  
Dented  
Over 30mm

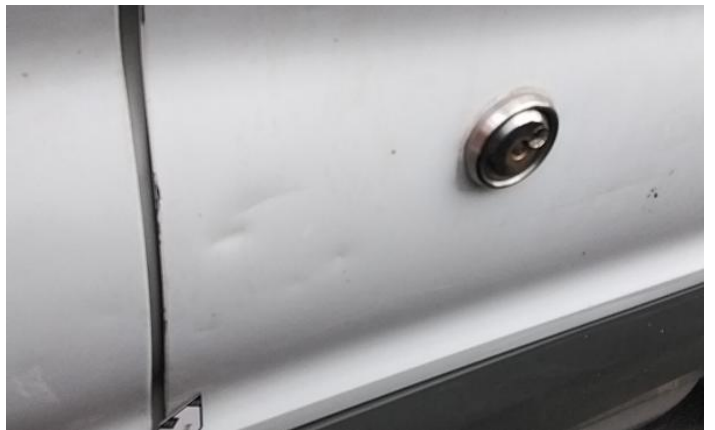
26: Door osf  
Dented  
Over 30mm

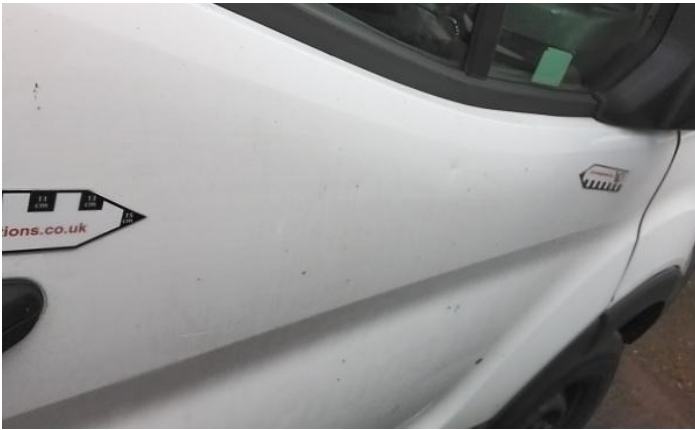
27: Door osf  
Dented  
Over 30mm

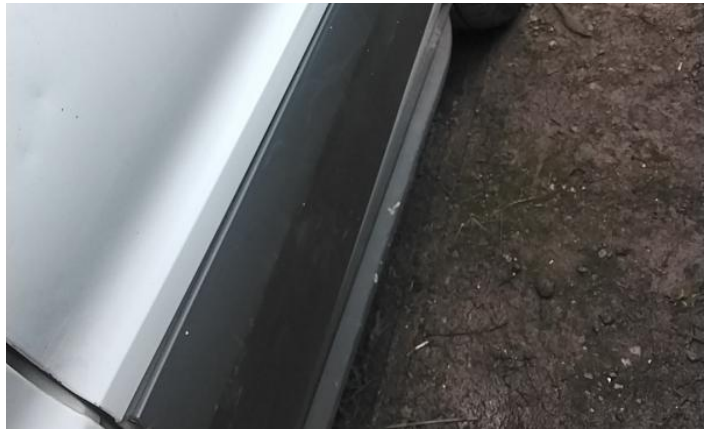
28: Door Moulding osf  
Broken  
Replace

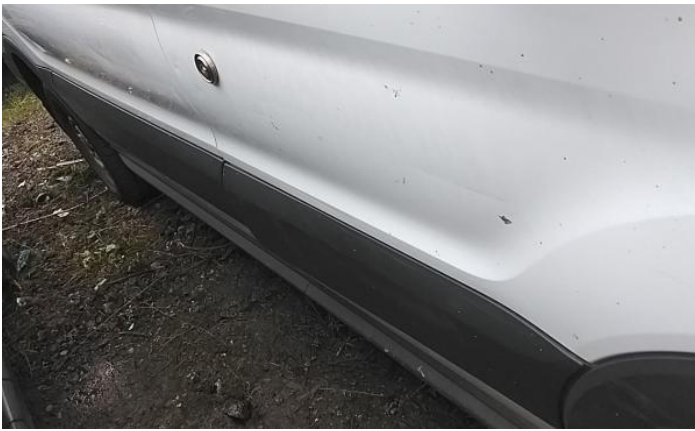
29: Door osf  
Chipped  
Multiple Chips

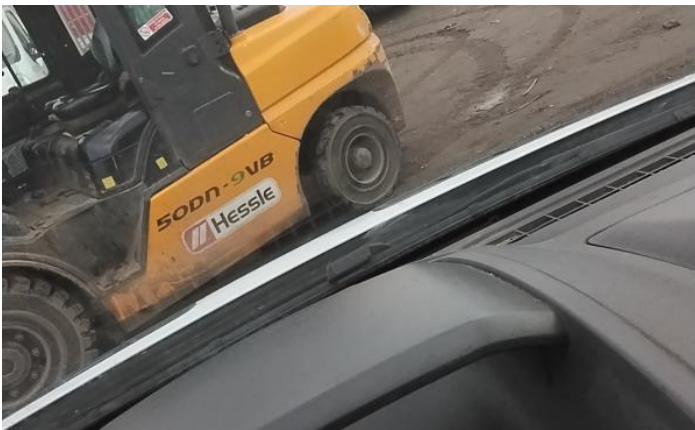
31: Screen Front  
Scratched  
Over 30mm

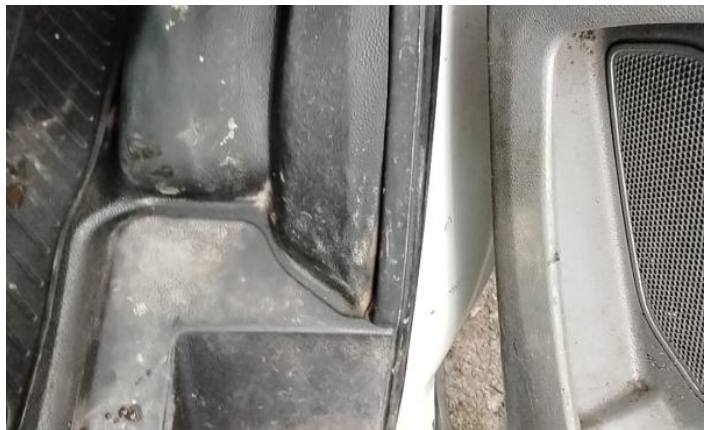
32: Carpets Front  
Soiled  
Heavy

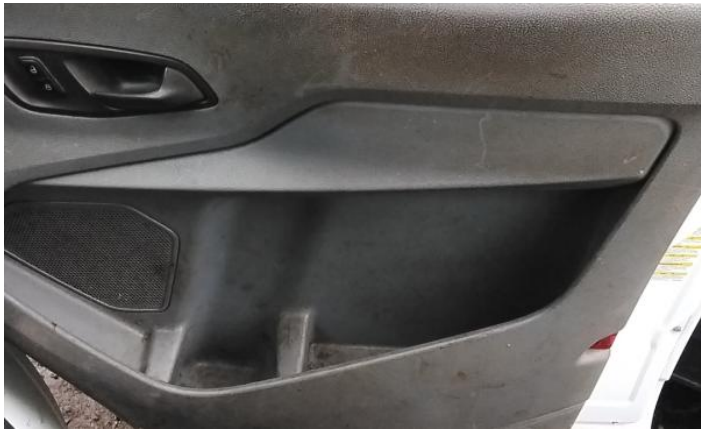
33: Door Pad osf  
Soiled  
Heavy

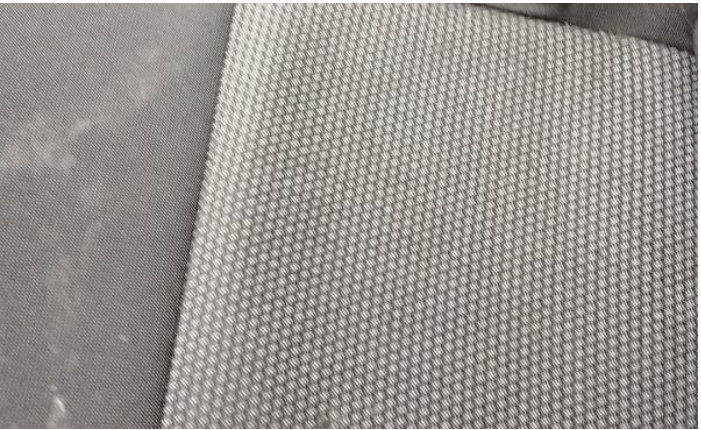
34: Seat Base Cover osf  
Torn  
Over 3mm

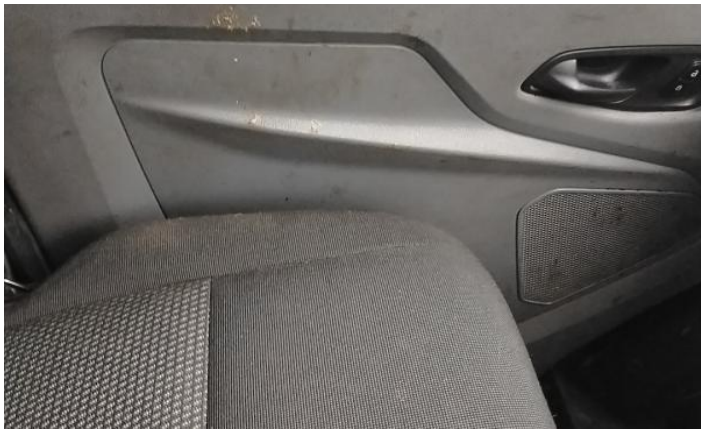
35: Door Pad nsf  
Soiled  
Heavy
