VEHICLE INSPECTION REPORT

LM66ZZN

Mercedes-Benz Sprinter 314 CDI

Inspection

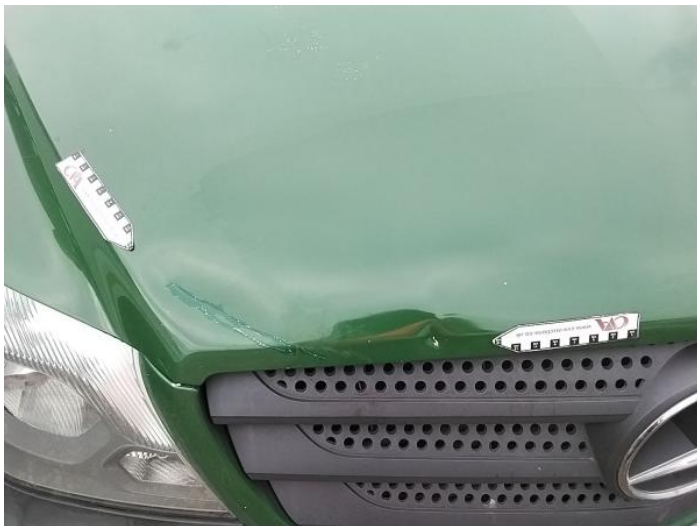
1: Bonnet
Dented
With Paint Damage

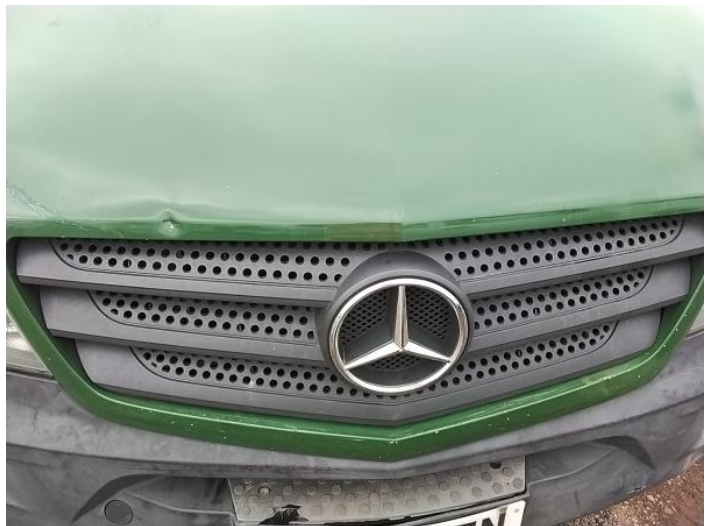
2: Bonnet
Chipped
Multiple Chips

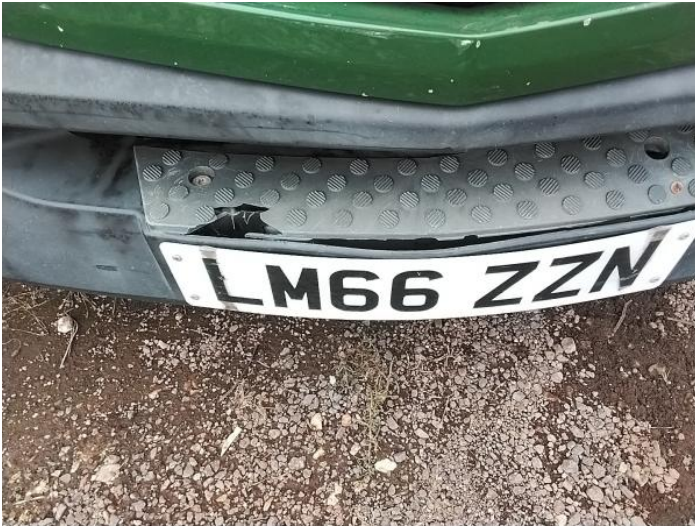
3: Bumper Front Moulding
Broken
Replace

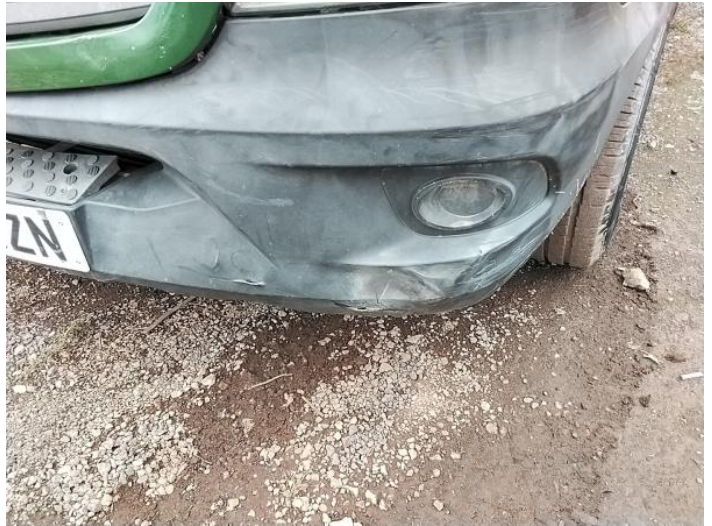
4: Bumper Front
Cracked
Over 25mm

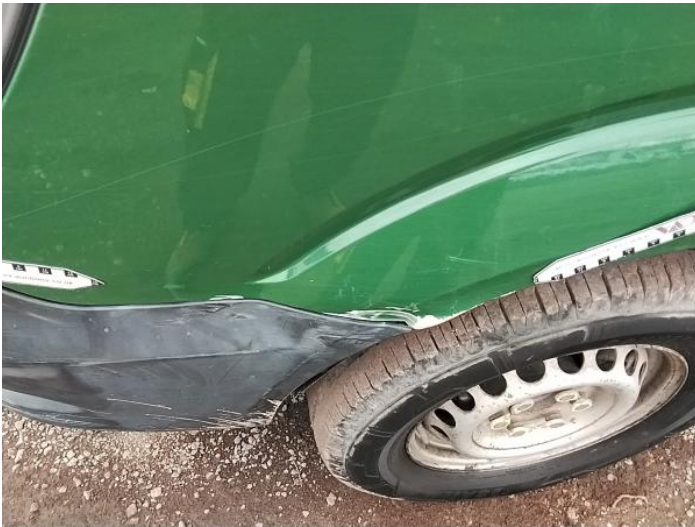
5: Wing nsf
Dented
With Paint Damage

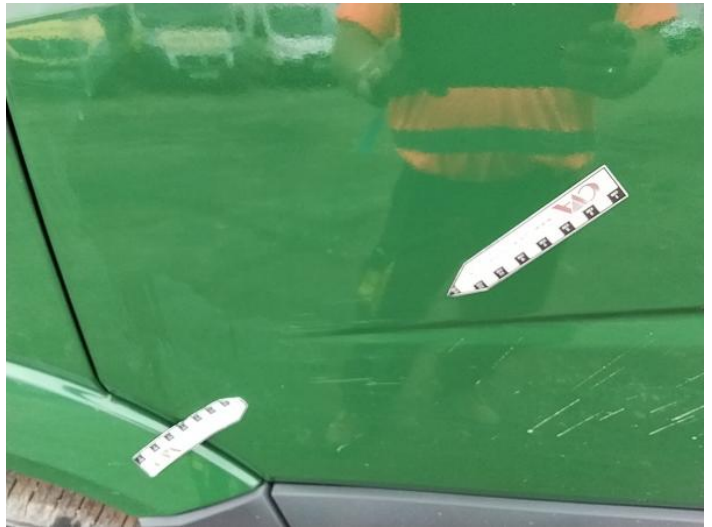
6: Door nsf
Scratched
Over 25mm Thru Paint

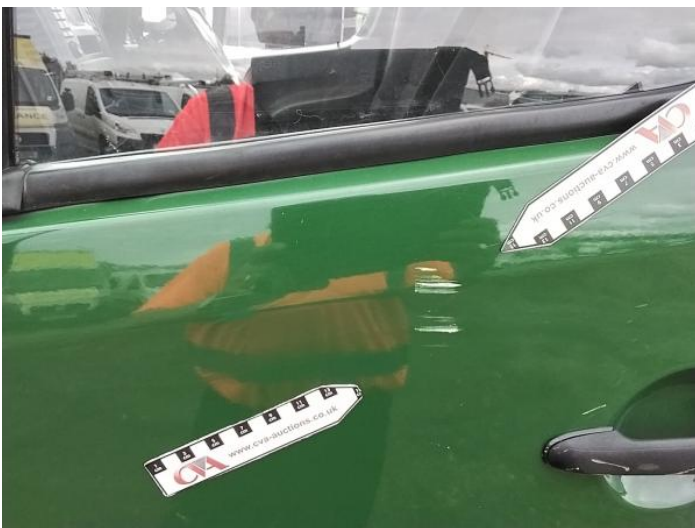
7: Door nsf
Dented
With Paint Damage

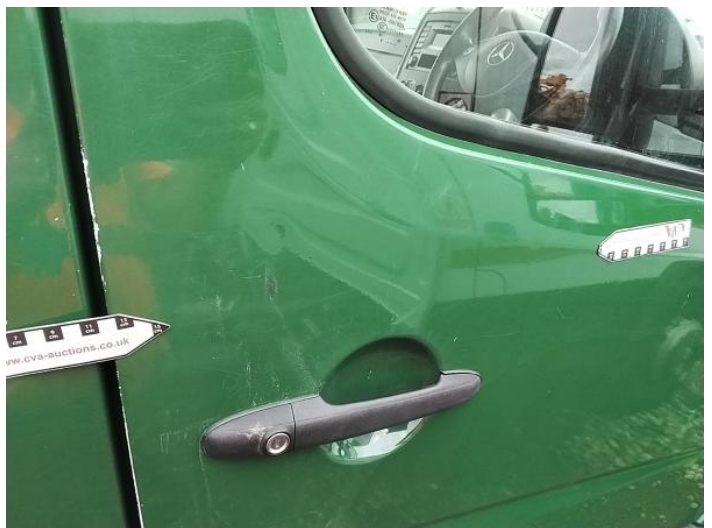
8: Door osf
Dented
Over 30mm

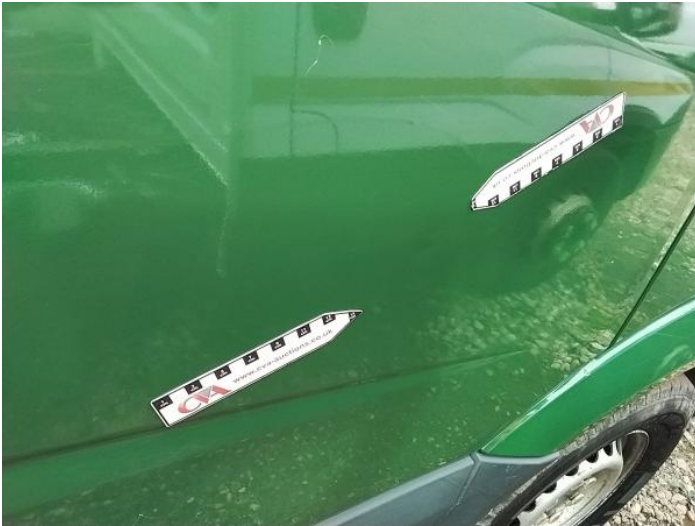
9: Door osf
Dented
Over 30mm

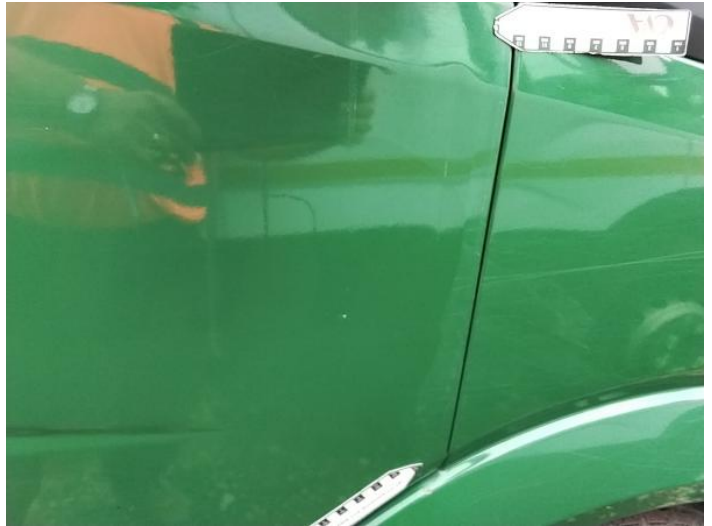
10: Door osf
Dented
Over 30mm

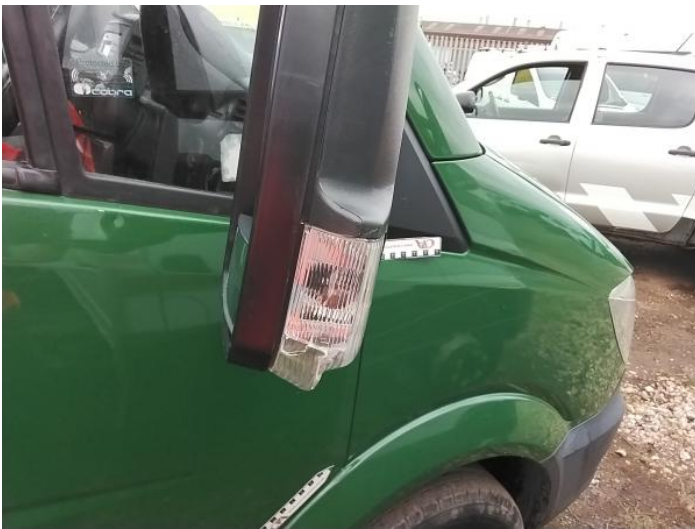
11: Door Mirror Assy osf
Broken
Replace

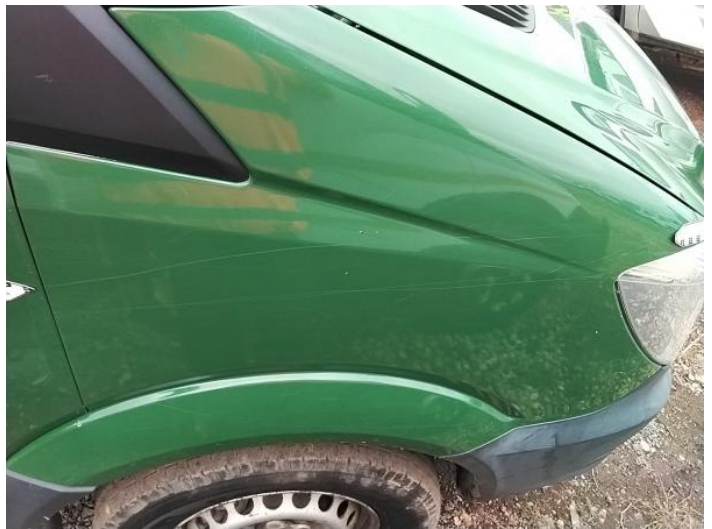
12: Wing osf
Scratched
Over 25mm Thru Paint

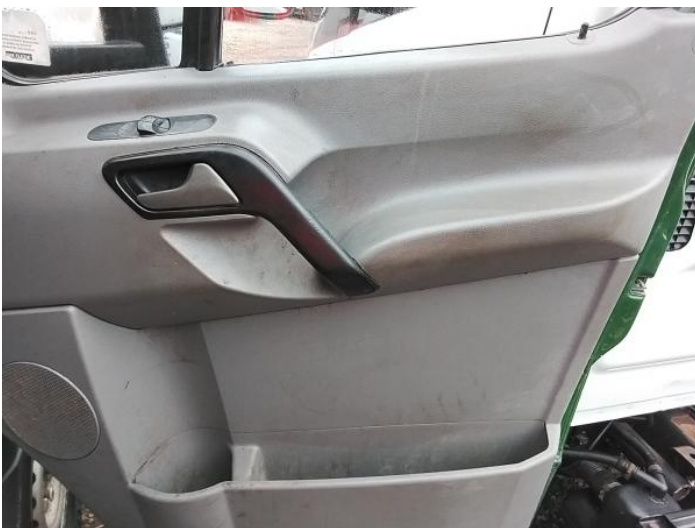
13: Door Pad osf
Soiled
Heavy

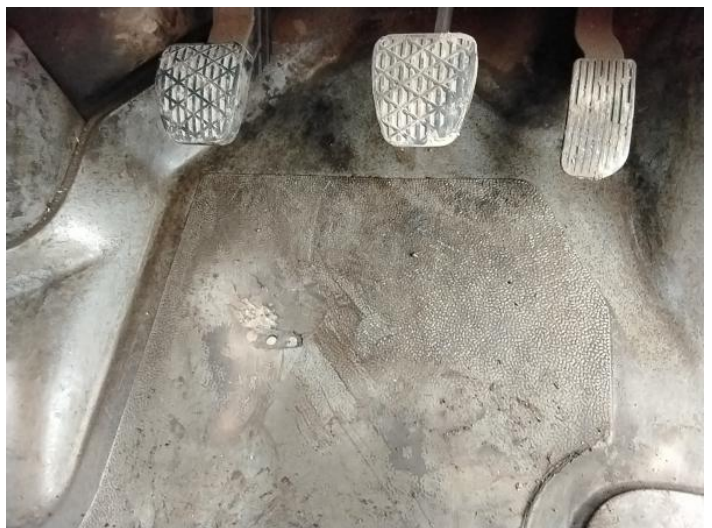
14: Carpets Front
Holed
Over 3mm

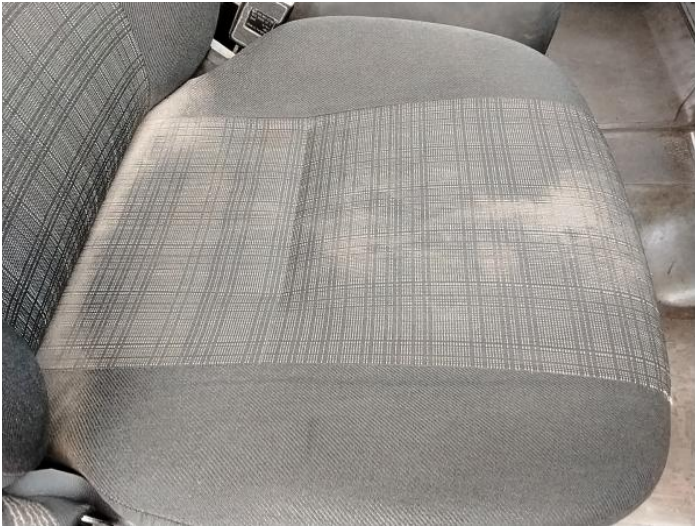
15: Seat Base Cover osf
Soiled
Heavy

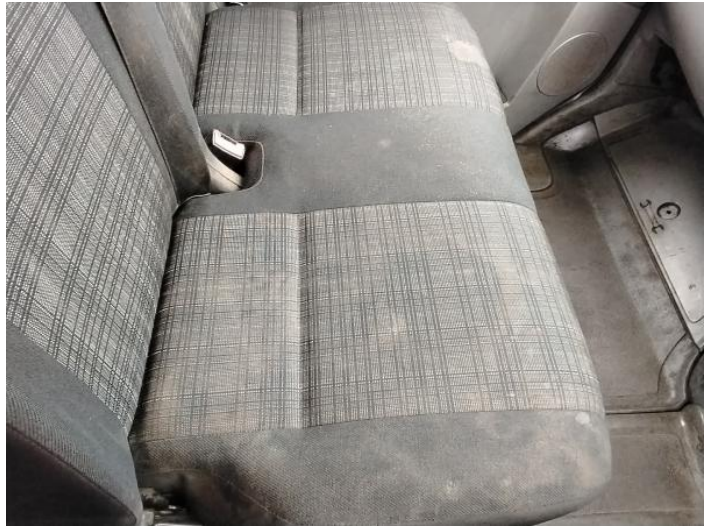
16: Seat Base Cover nsf
Soiled
Heavy

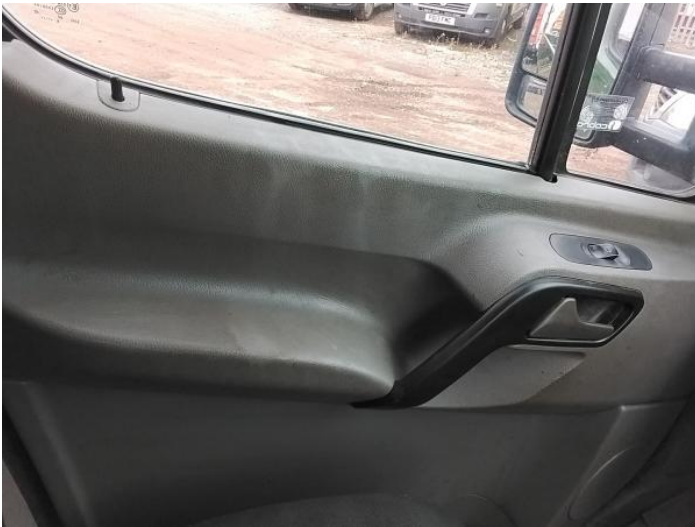
17: Door Pad nsf
Soiled
Heavy

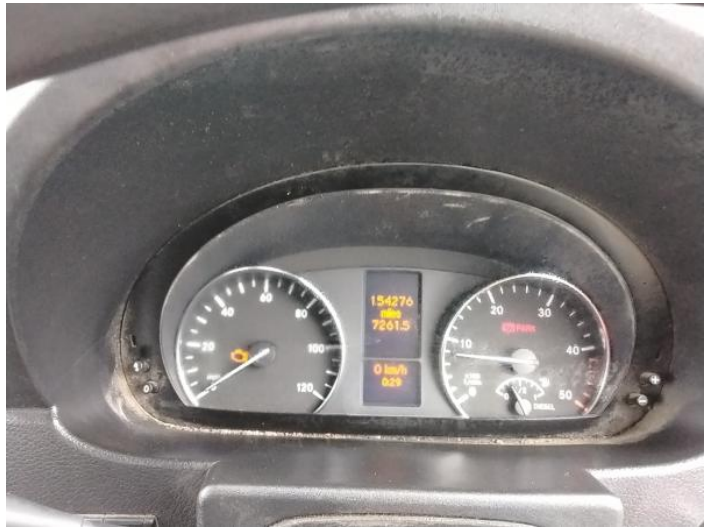
*OUTSTANDING RECALL **WARNING LIGHT ON DASH* AD-BLUE

18: Dash Warning Lights
Displayed
No Action

Engine Runs	OK	No Excessive Smoking	OK
EML light illuminated	Fault	DPF light illuminated	OK
ABS light illuminated	OK
