# VEHICLE INSPECTION REPORT

**WR20DWU**

## Fiat Ducato 35 2.3 MULTIJET 140PS

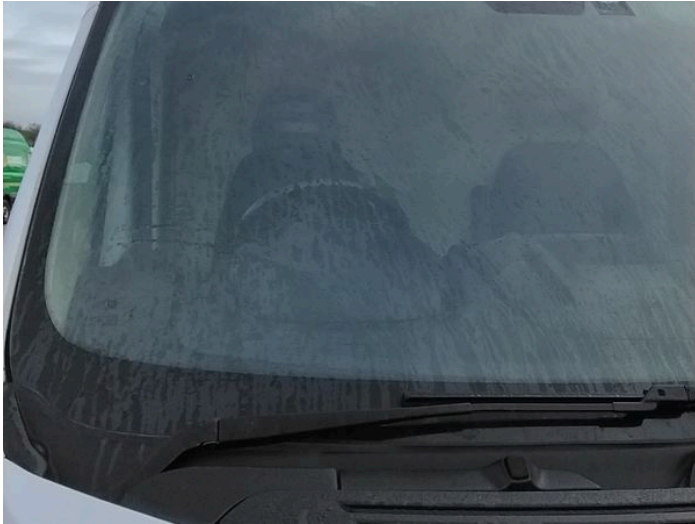
1: Screen Front  
Chipped  
Over 10mm

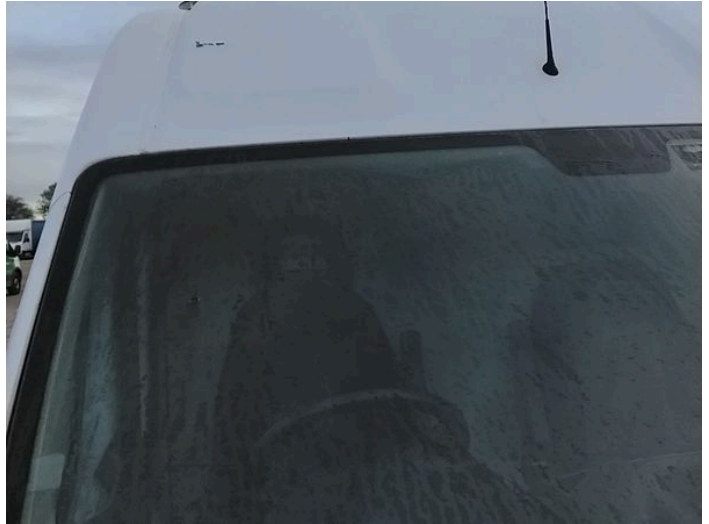
2: Roof  
Dented  
With Paint Damage

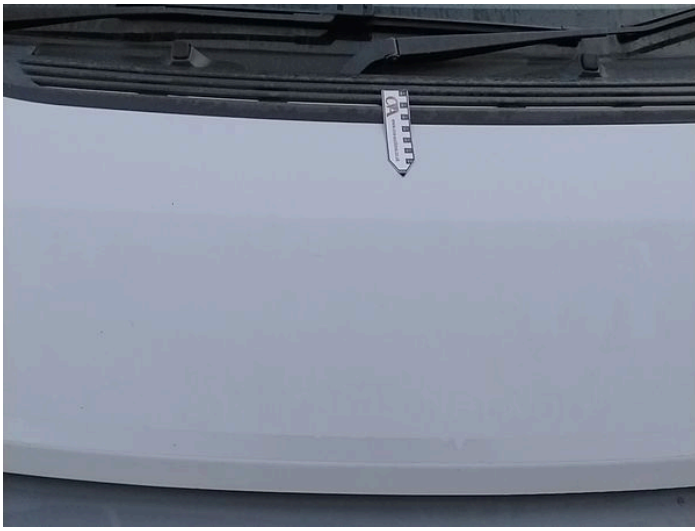
3: Bonnet  
Chipped  
Multiple Chips

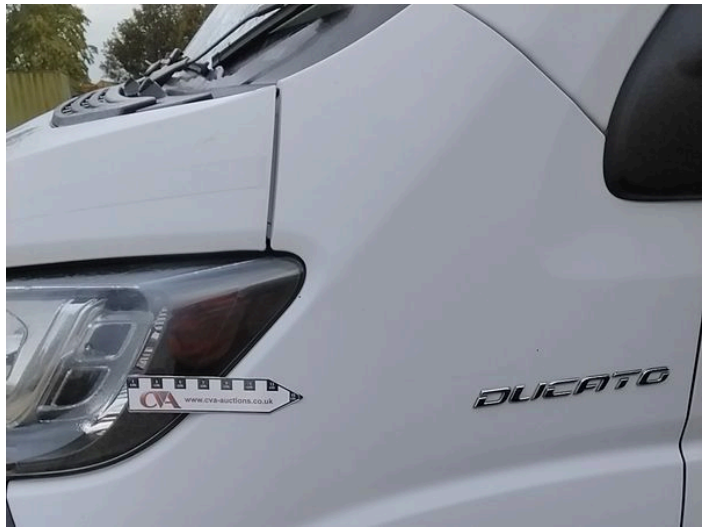
4: Wing nsf  
Scratched  
Over 25mm Not Thru Paint

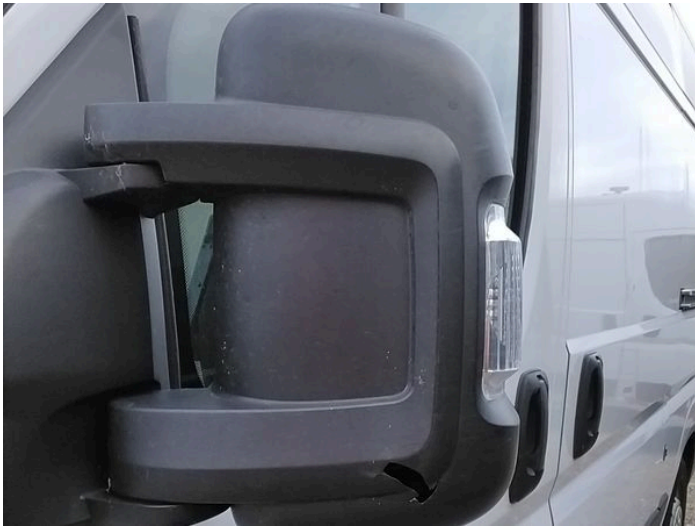
5: Door Mirror Assy nsf  
Broken  
Replace

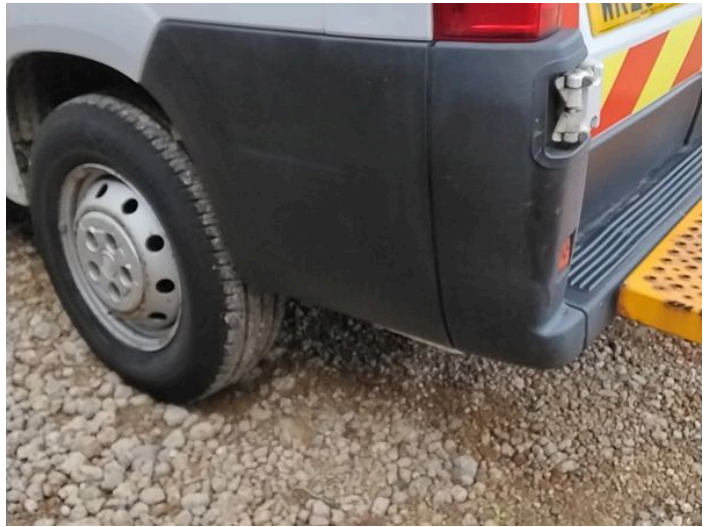
6: Bumper Rear Moulding  
Scuffed (Unpainted)  
UpTo 100mm

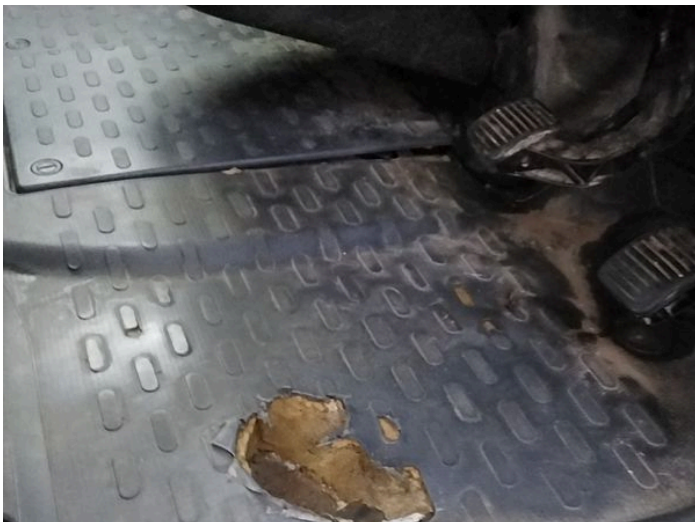
7: Carpets Front  
Holed  
Over 3mm

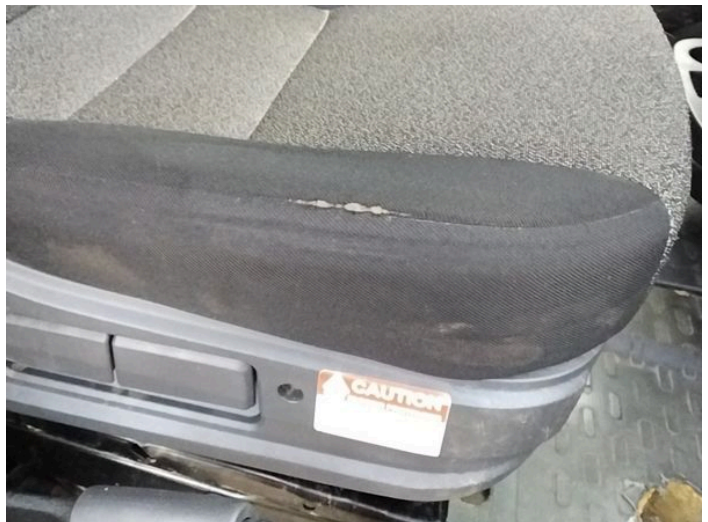
8: Seat Base Cover osf  
Holed  
Over 3mm
