VEHICLE INSPECTION REPORT

BF18YRU

Fiat Ducato 35 2.3 MULTIJET 150PS

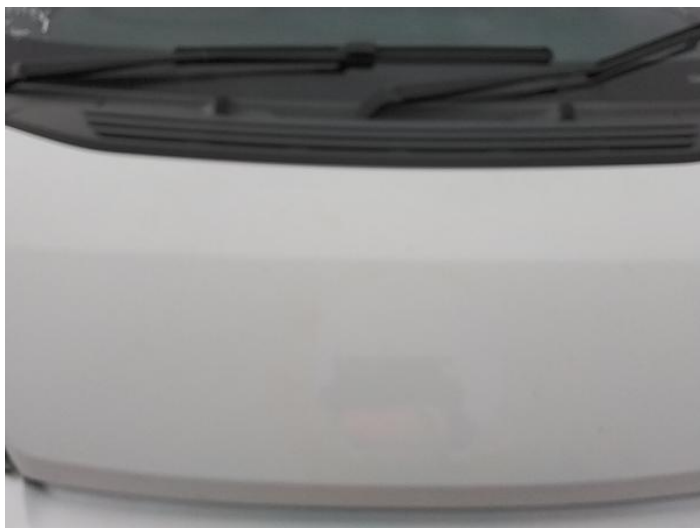
1: Bonnet
Chipped
Multiple Chips

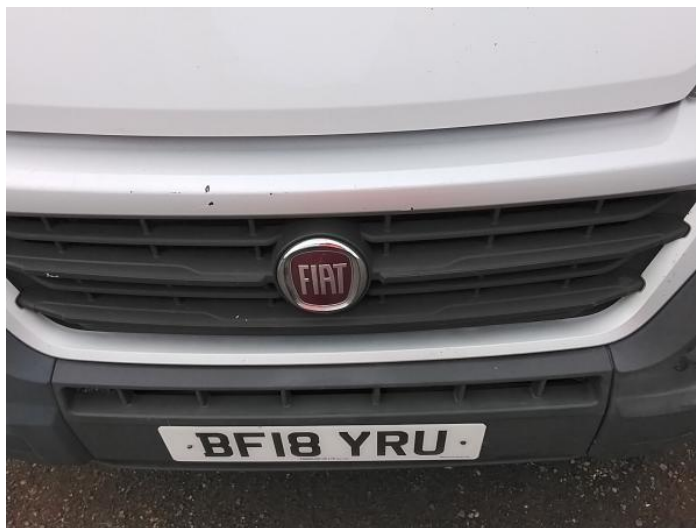
2: Panel Front
Chipped
Multiple Chips

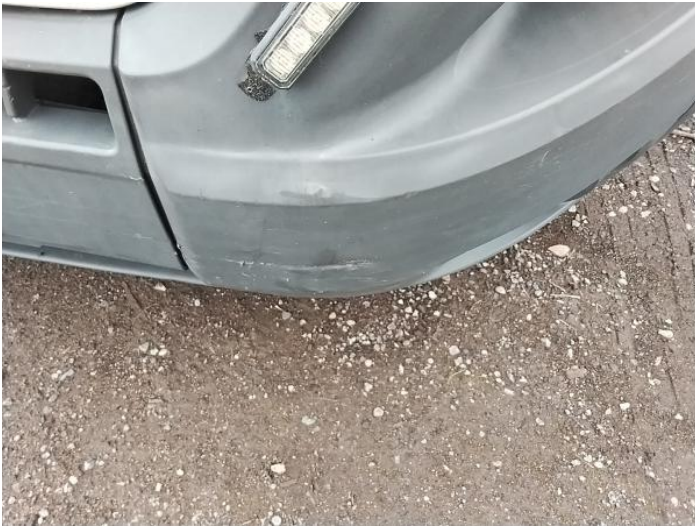
3: Bumper Front
Dented
Over 30mm

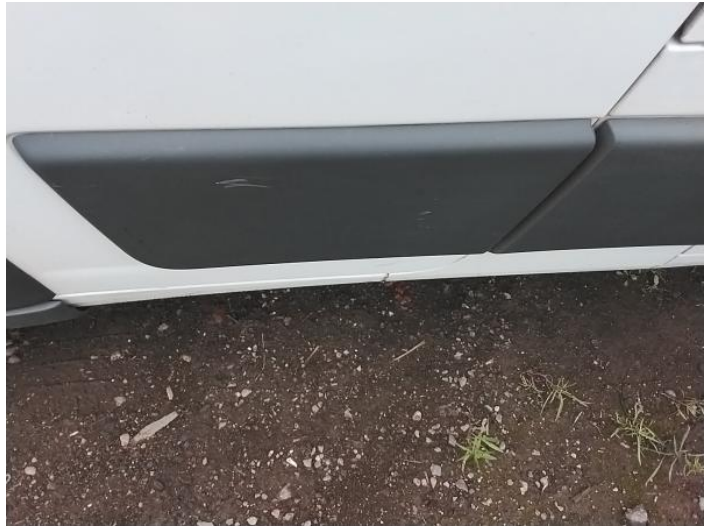
4: Door Moulding nsf
Scuffed (Unpainted)
UpTo 100mm

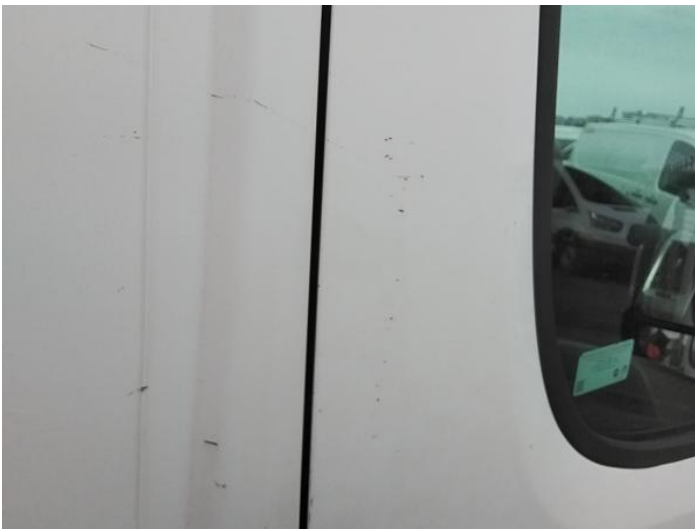
5: Door osf
Chipped
Multiple Chips

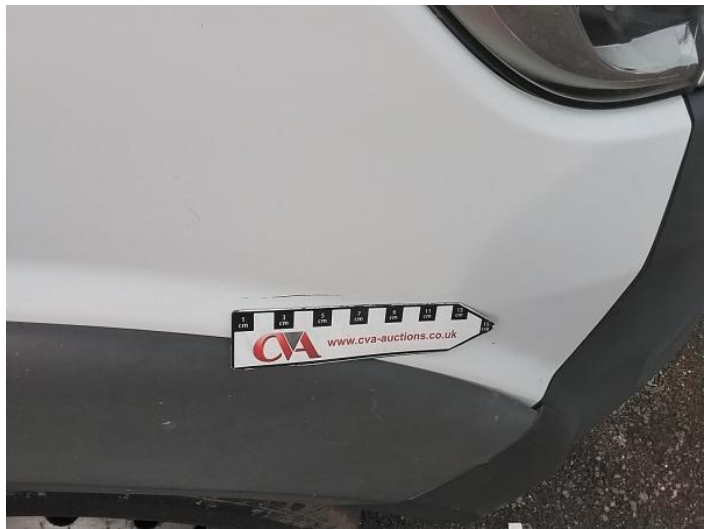
6: Wing osf
Scratched
Over 25mm Thru Paint

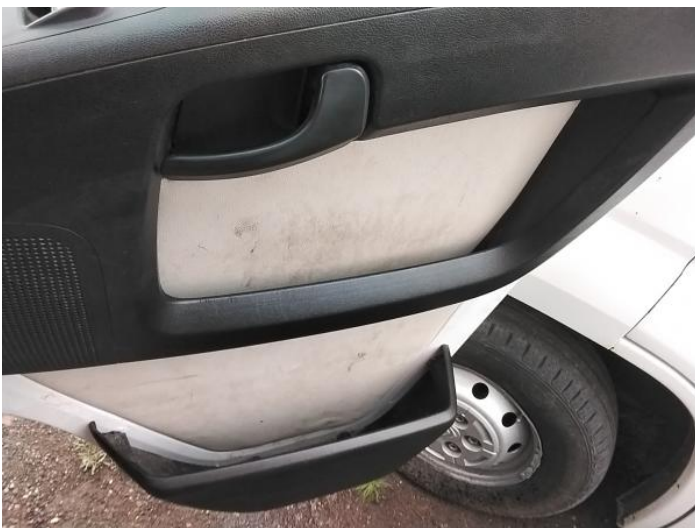
7: Door Pad osf
Soiled
Heavy

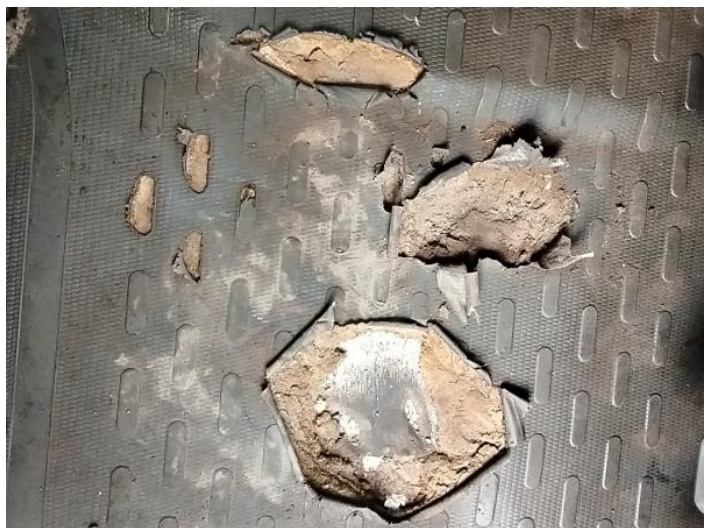
8: Carpets Front
Holed
Over 3mm

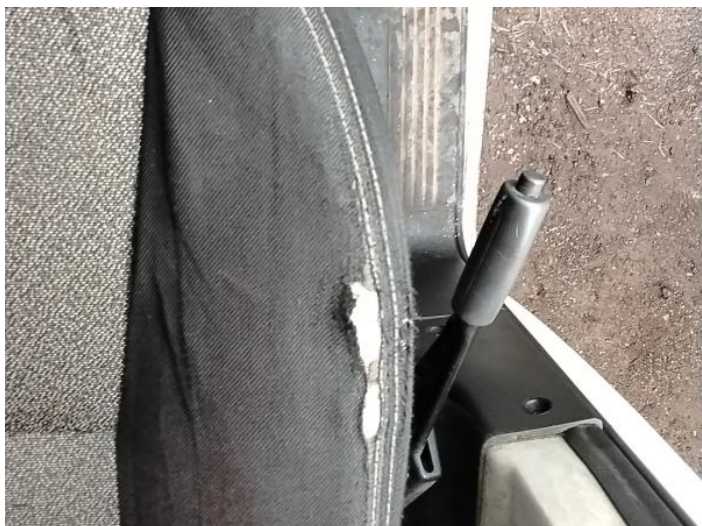
9: Seat Base Cover osf
Torn
Over 3mm
